FRED AFLAKIAN, PG, CEG
CONSULTING ENGINEERING GEOLOGIST

Project No.19-805 Fault

Subject: Fault Rupture Hazard Investigation, Proposed S2A Showroom and Factory Compound, APNs 439-030-009, 439-030-010 and 439-400-023, West of State Street and Crow's Nest Place, City of Hemet, Riverside County, California

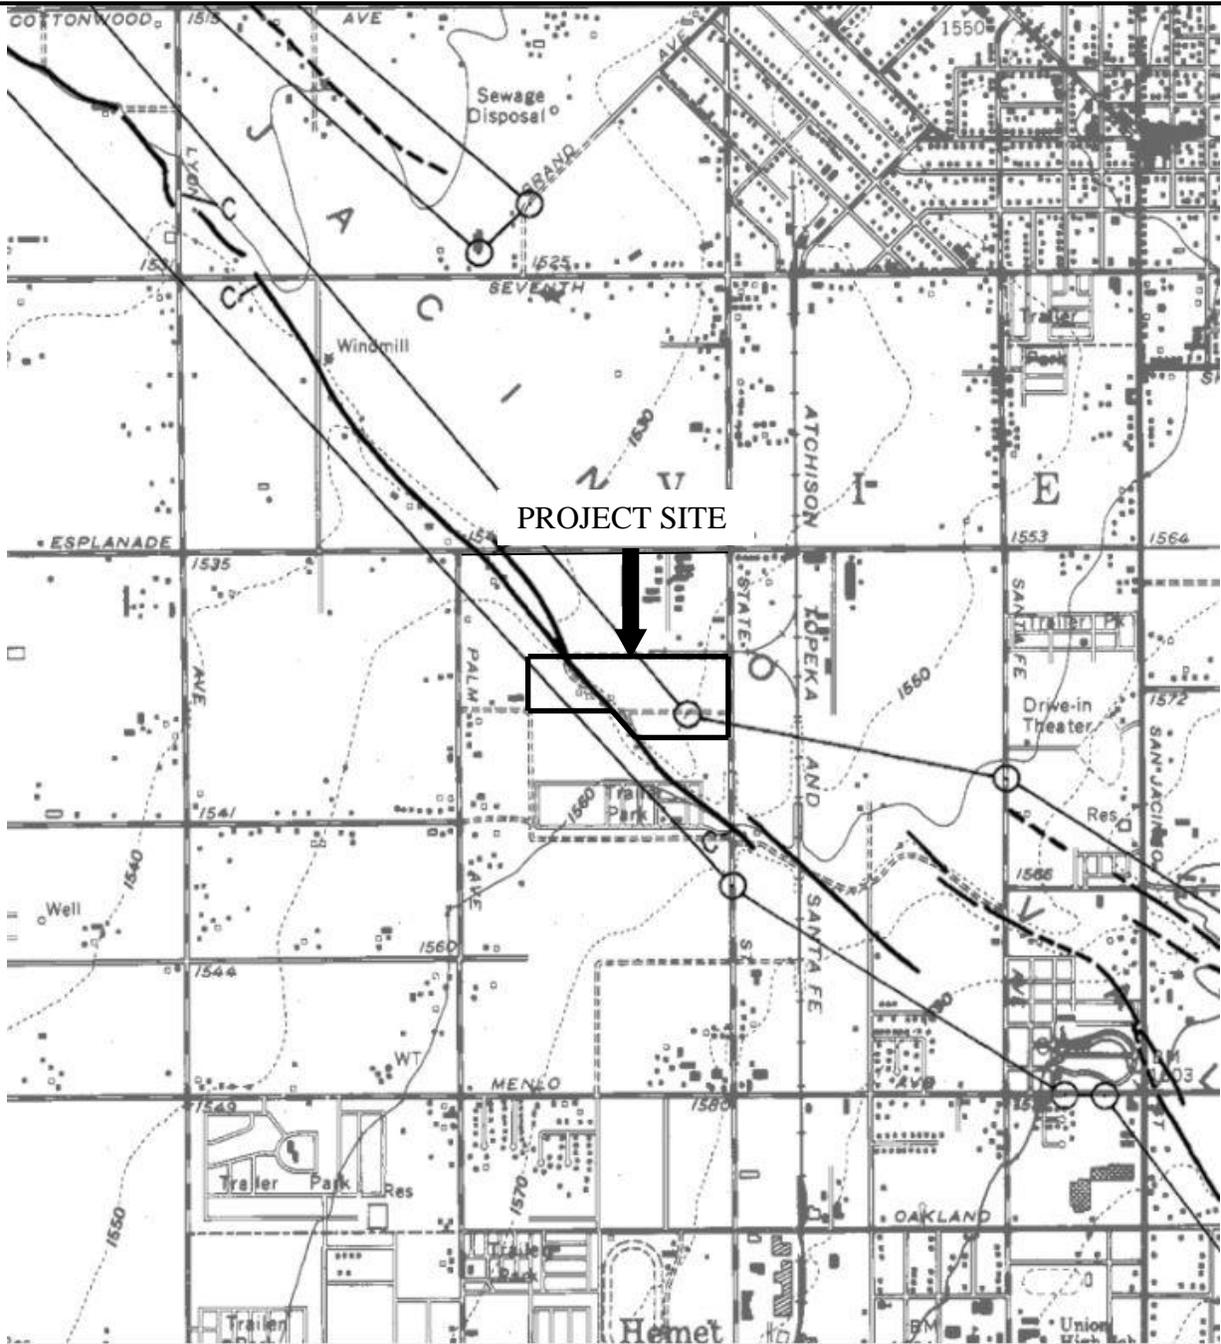
<p align="center">SITE ALQUIST-PRIOLO MAP</p>		<p align="center">Project No: 19-805 Fault</p>	
<p align="center">S2A Modular Factory and Showroom, City of Hemet, California</p>			
<p align="center">FRED AFLAKIAN, PG, CEG</p>		<p align="center">FIGURE</p>	<p align="center">3</p>

The active, northwest trending fault passing through the western portion of the site is the Casa Loma fault, a branch of the San Jacinto fault zone (See Figure 3, Site Alquist-Priolo Map). The block of land between the on-site Casa Loma fault and the Claremont fault, approximately 3 miles to the northeast, is a large graben (down-thrown block of land between faults) that has historically undergone subsidence of up to 4 feet in some places. Both the Casa Loma and Claremont faults are part of the San Jacinto fault zone (Sharp, 1975). The graben between these faults is underlain by several thousand feet of alluvial sediments, whereas the alluvial sediments southwest of the Casa Loma fault only continue to depths of approximately 500 feet (Fett, 1968). Igneous, bedrock hills are located southwest of the Casa Loma fault. Metamorphic and igneous rocks, regionally capped by Pleistocene sediments, are located along the northeast side of the Claremont fault.

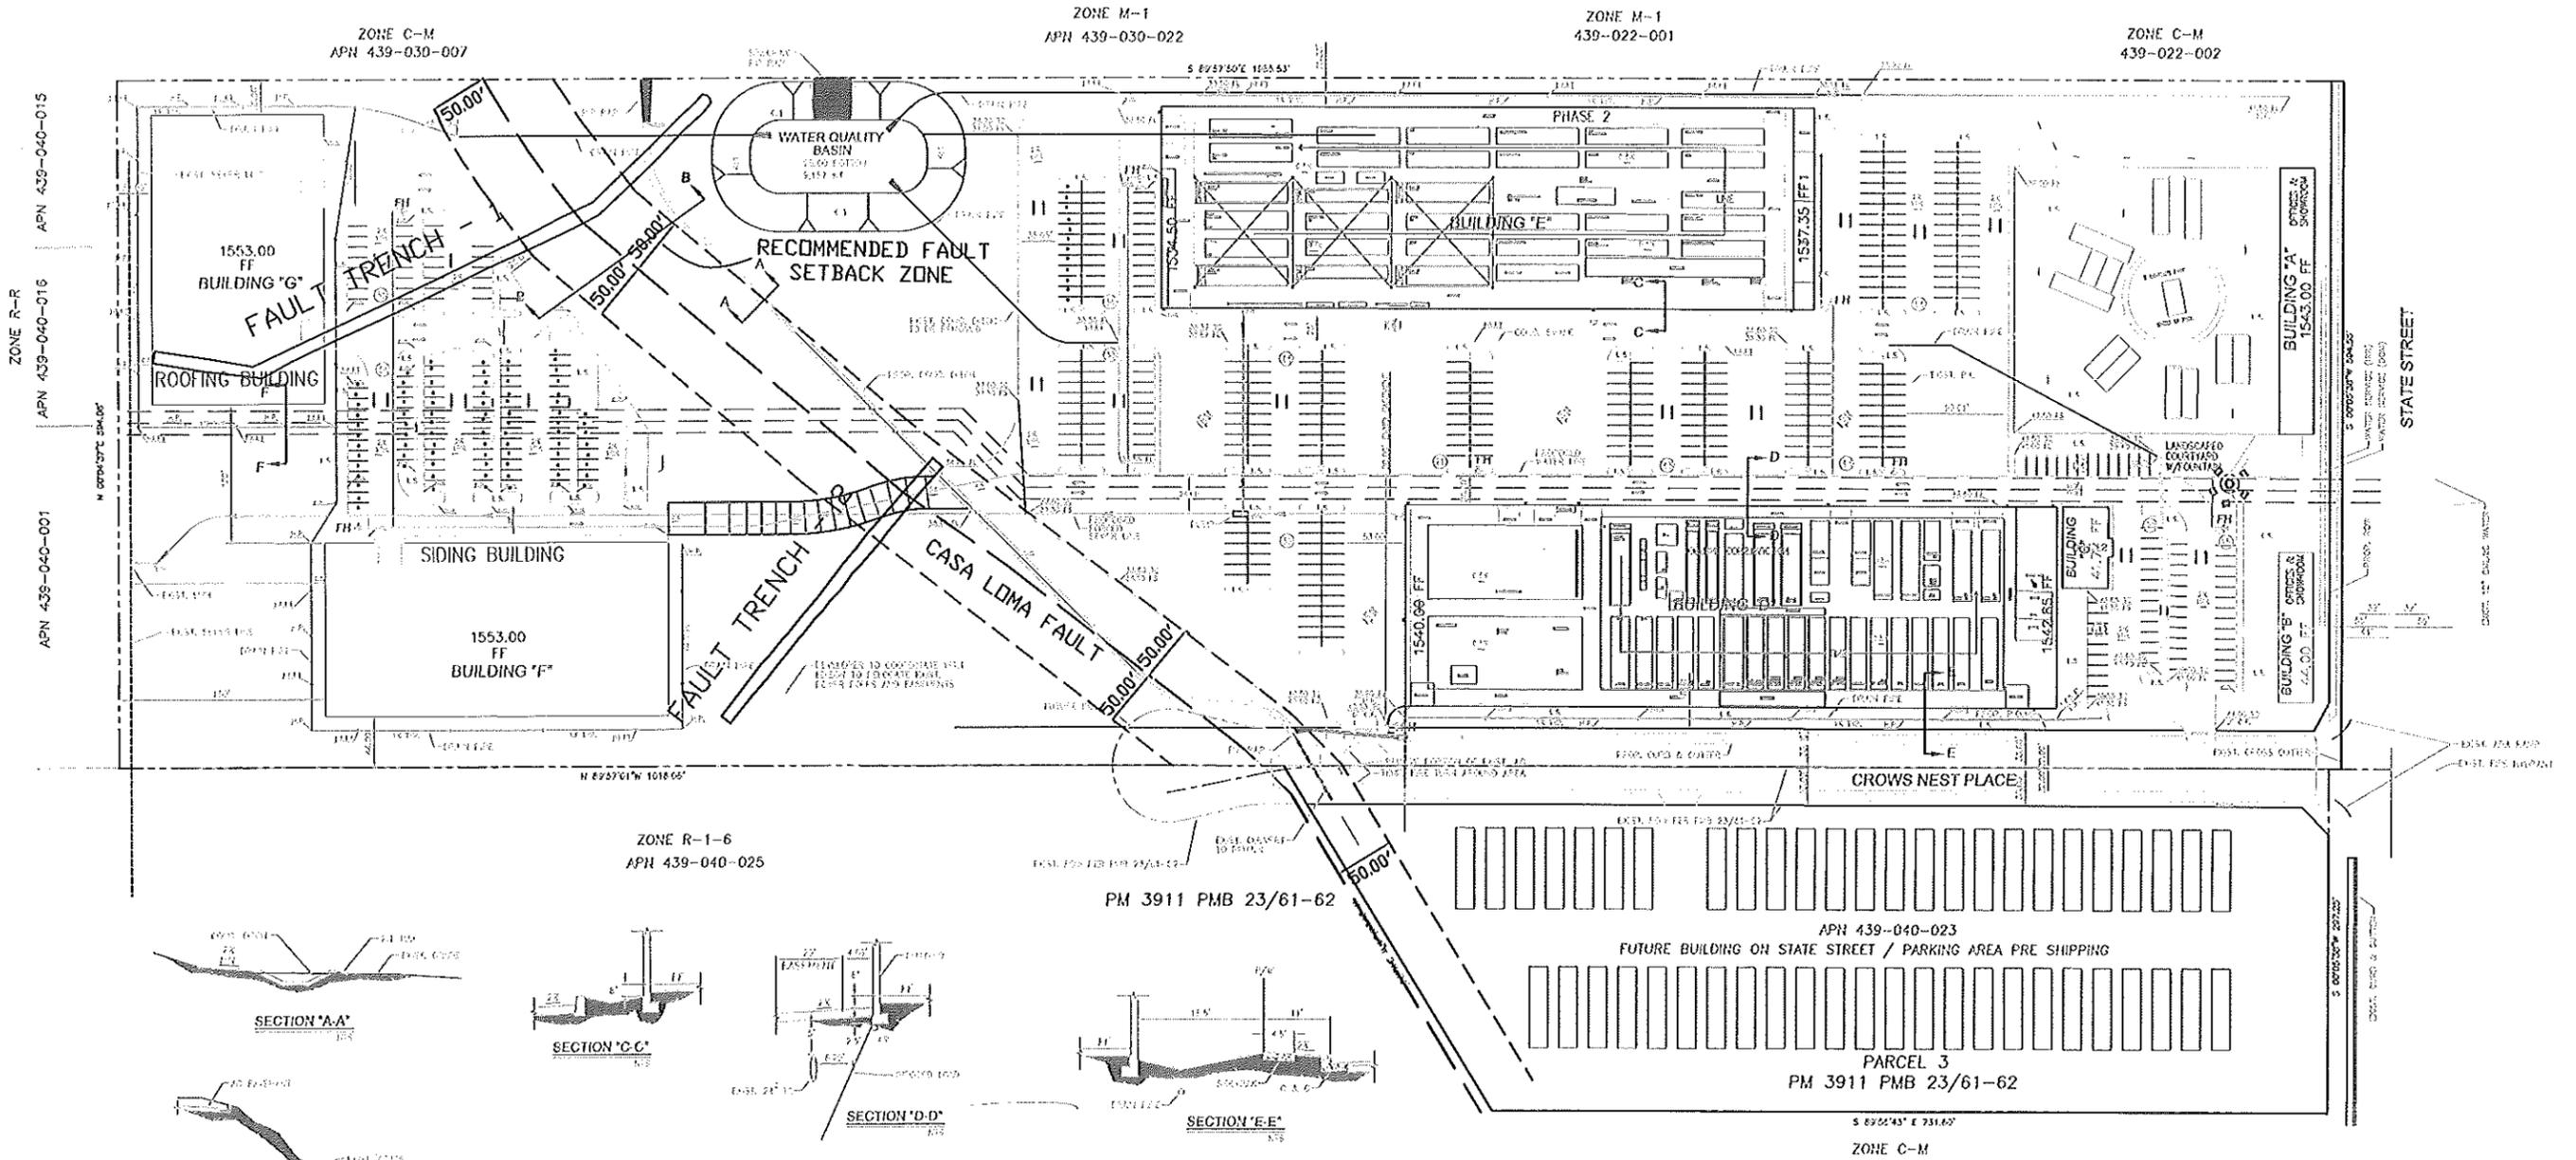
**PLATE 1
 FAULT TRENCH LOCATION MAP**

The surface locations of the major fault break were mapped. The mapped trend of the fault, as shown on Plate 1 (Fault Trench Location Map) was based on both the trend of the fault in the fault trenches as well as the trend of the fault scarp based on our review of aerial photographs. Human occupancy structures are not recommended across or within the designated fault setback zone as shown on Plate 1, Fault Trench Location Map.

Structures for human occupancy should not be placed in or across the designated fault setback zone shown on the enclosed fault trench location map (Plate 1).

Shut-off valves are recommended for any wet utilities (sewer and water) crossing the designated fault setback zone. The shut-off valves should be placed on either side of the zone.

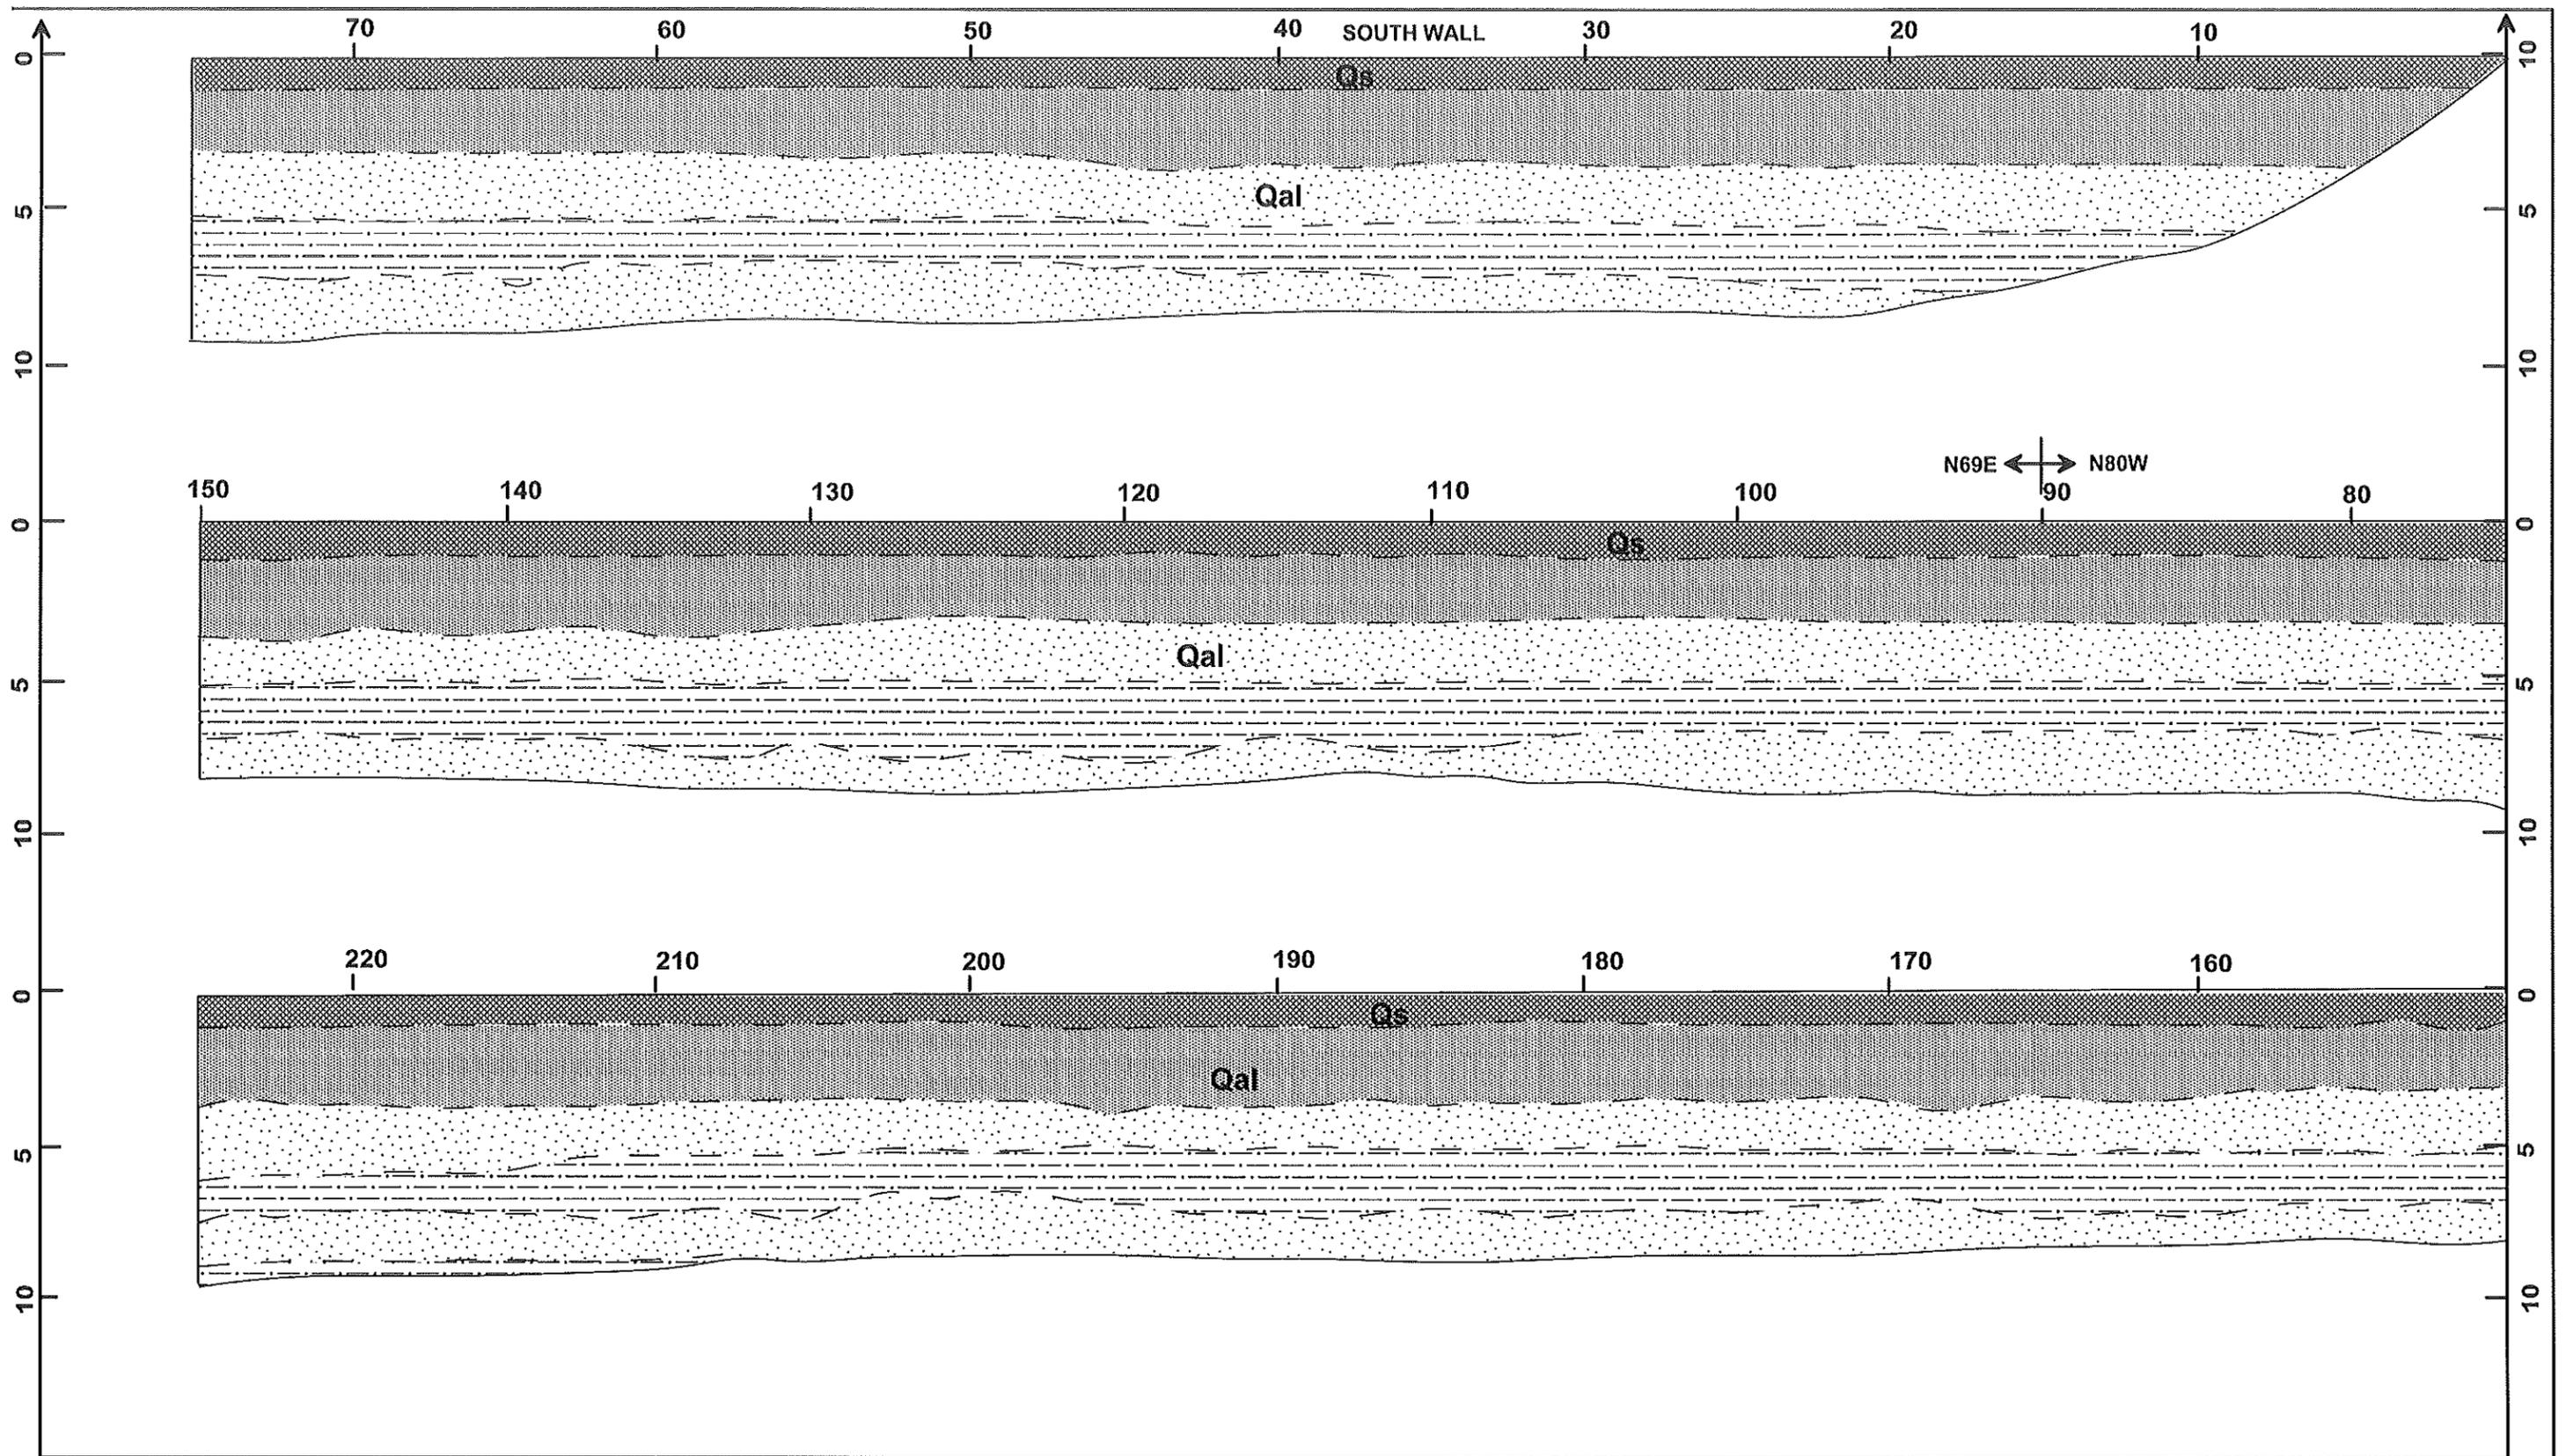
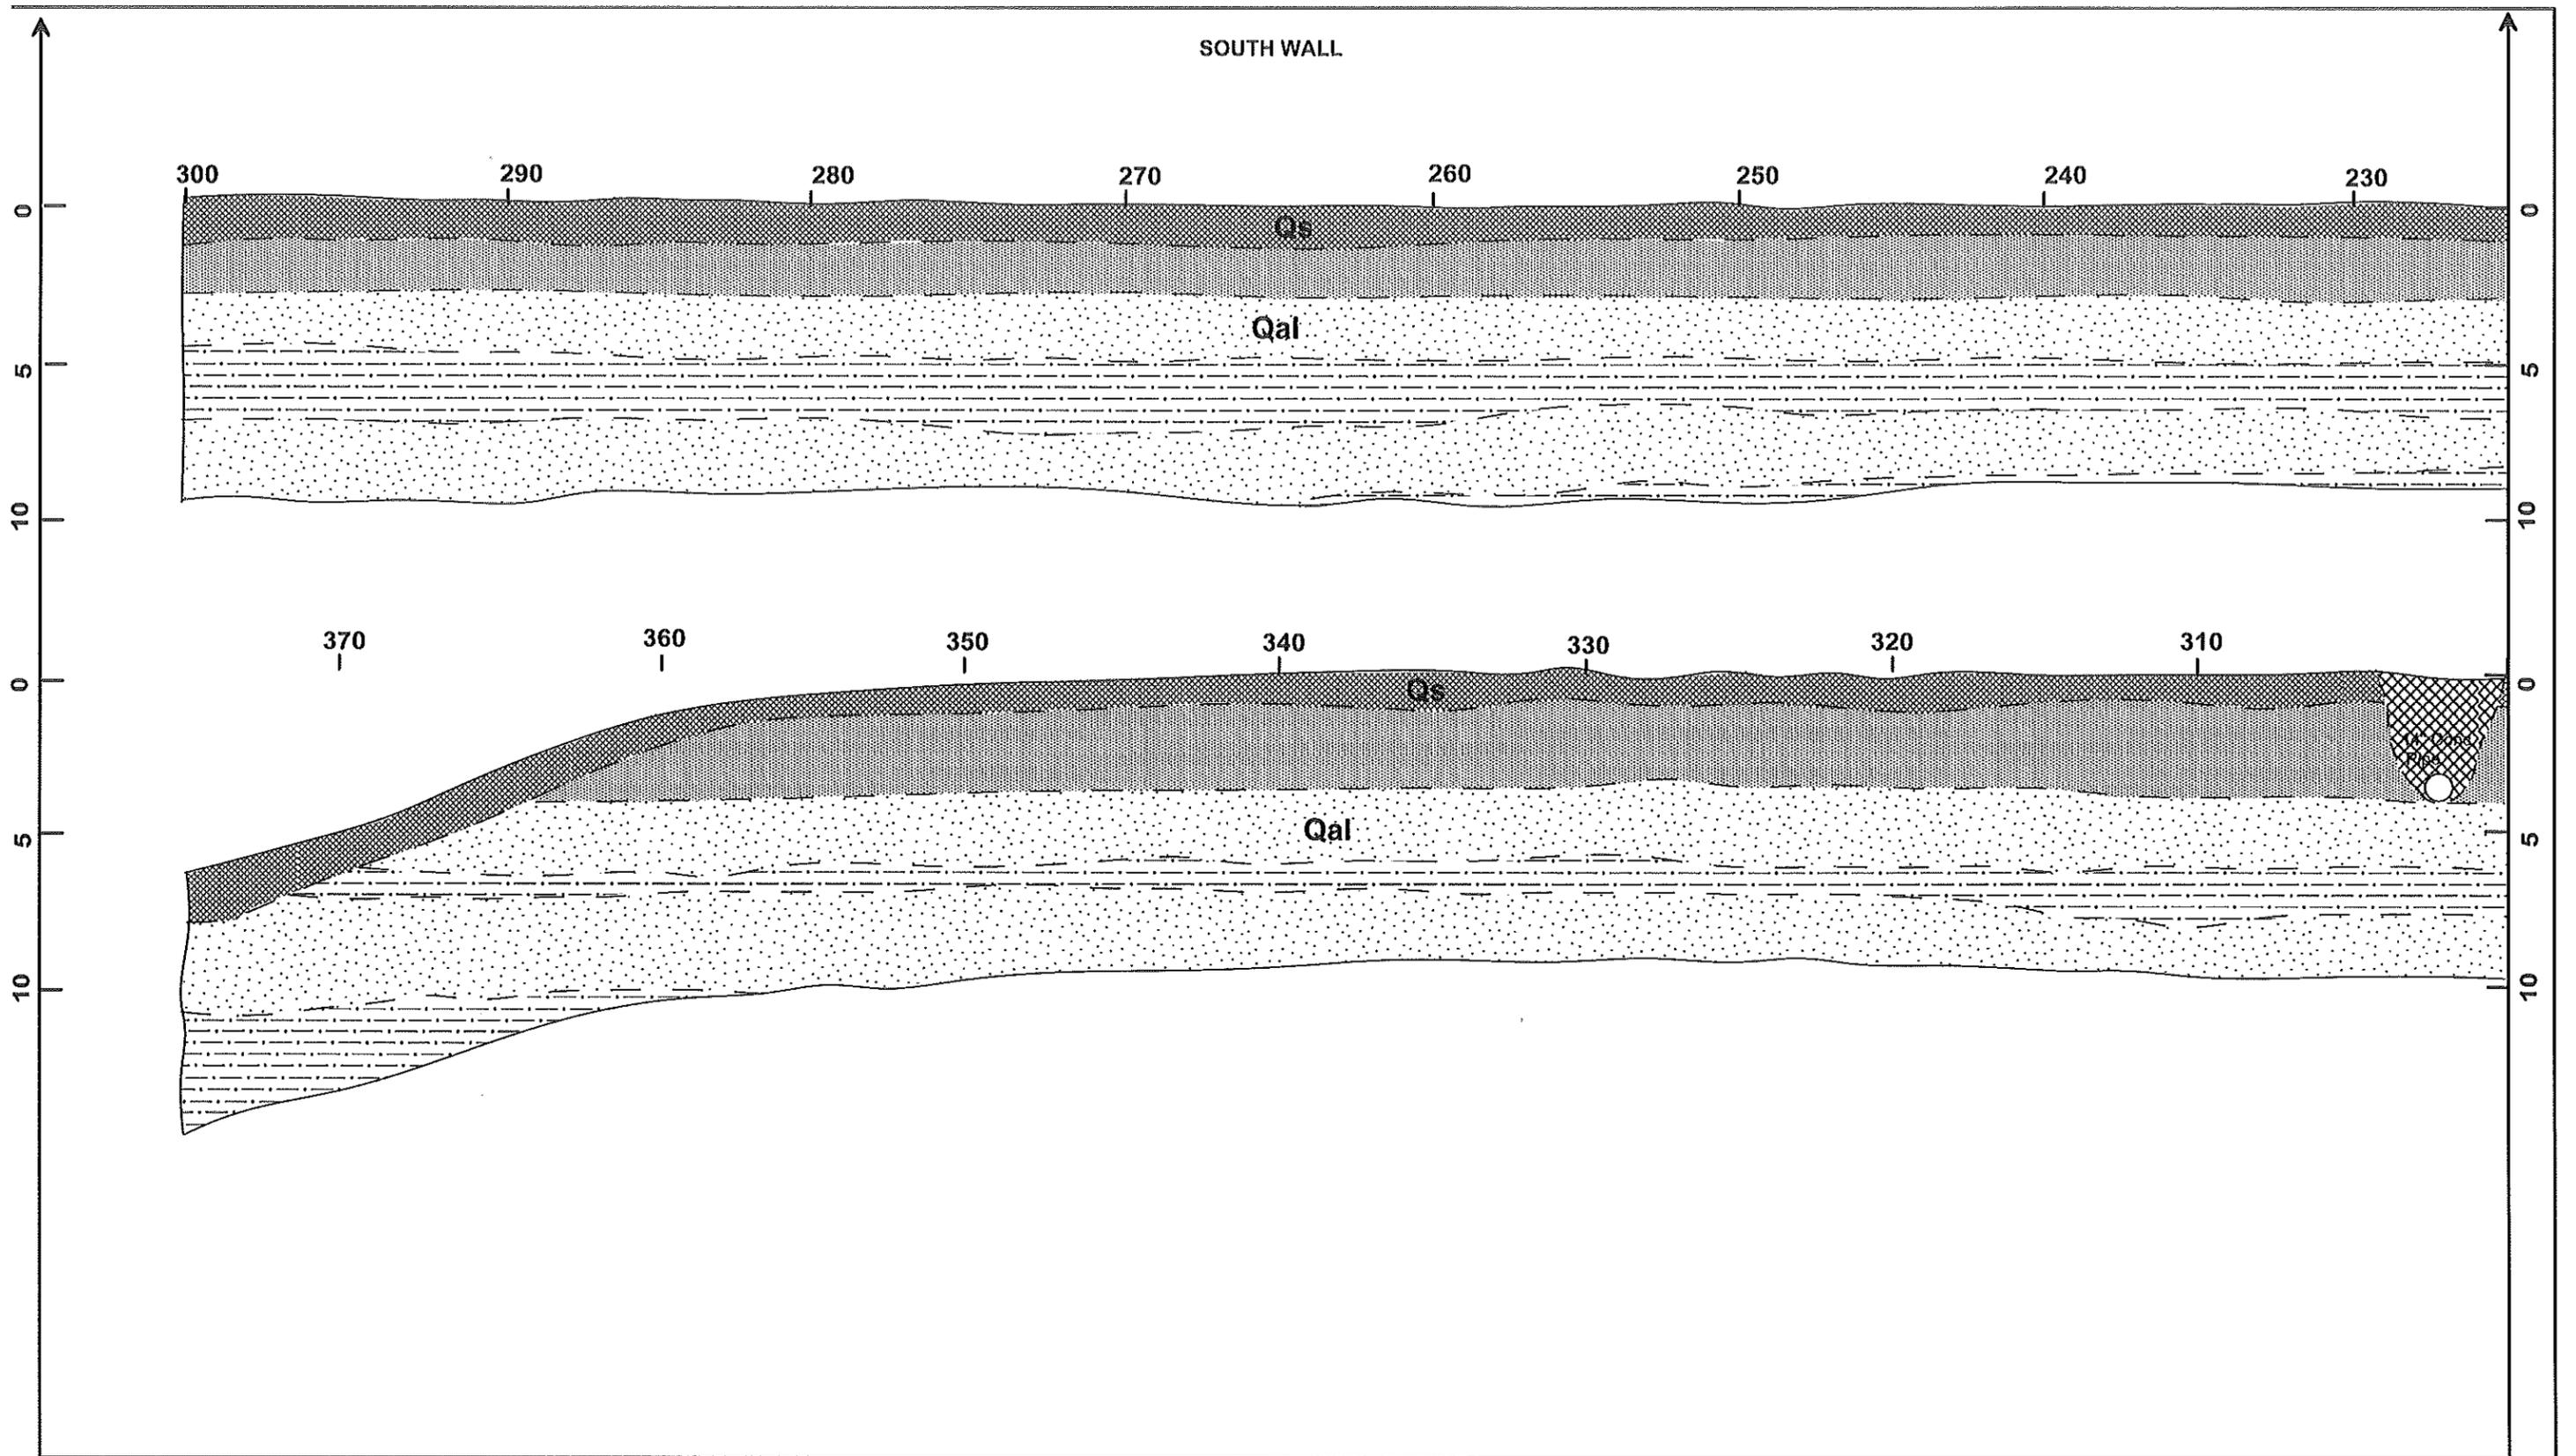
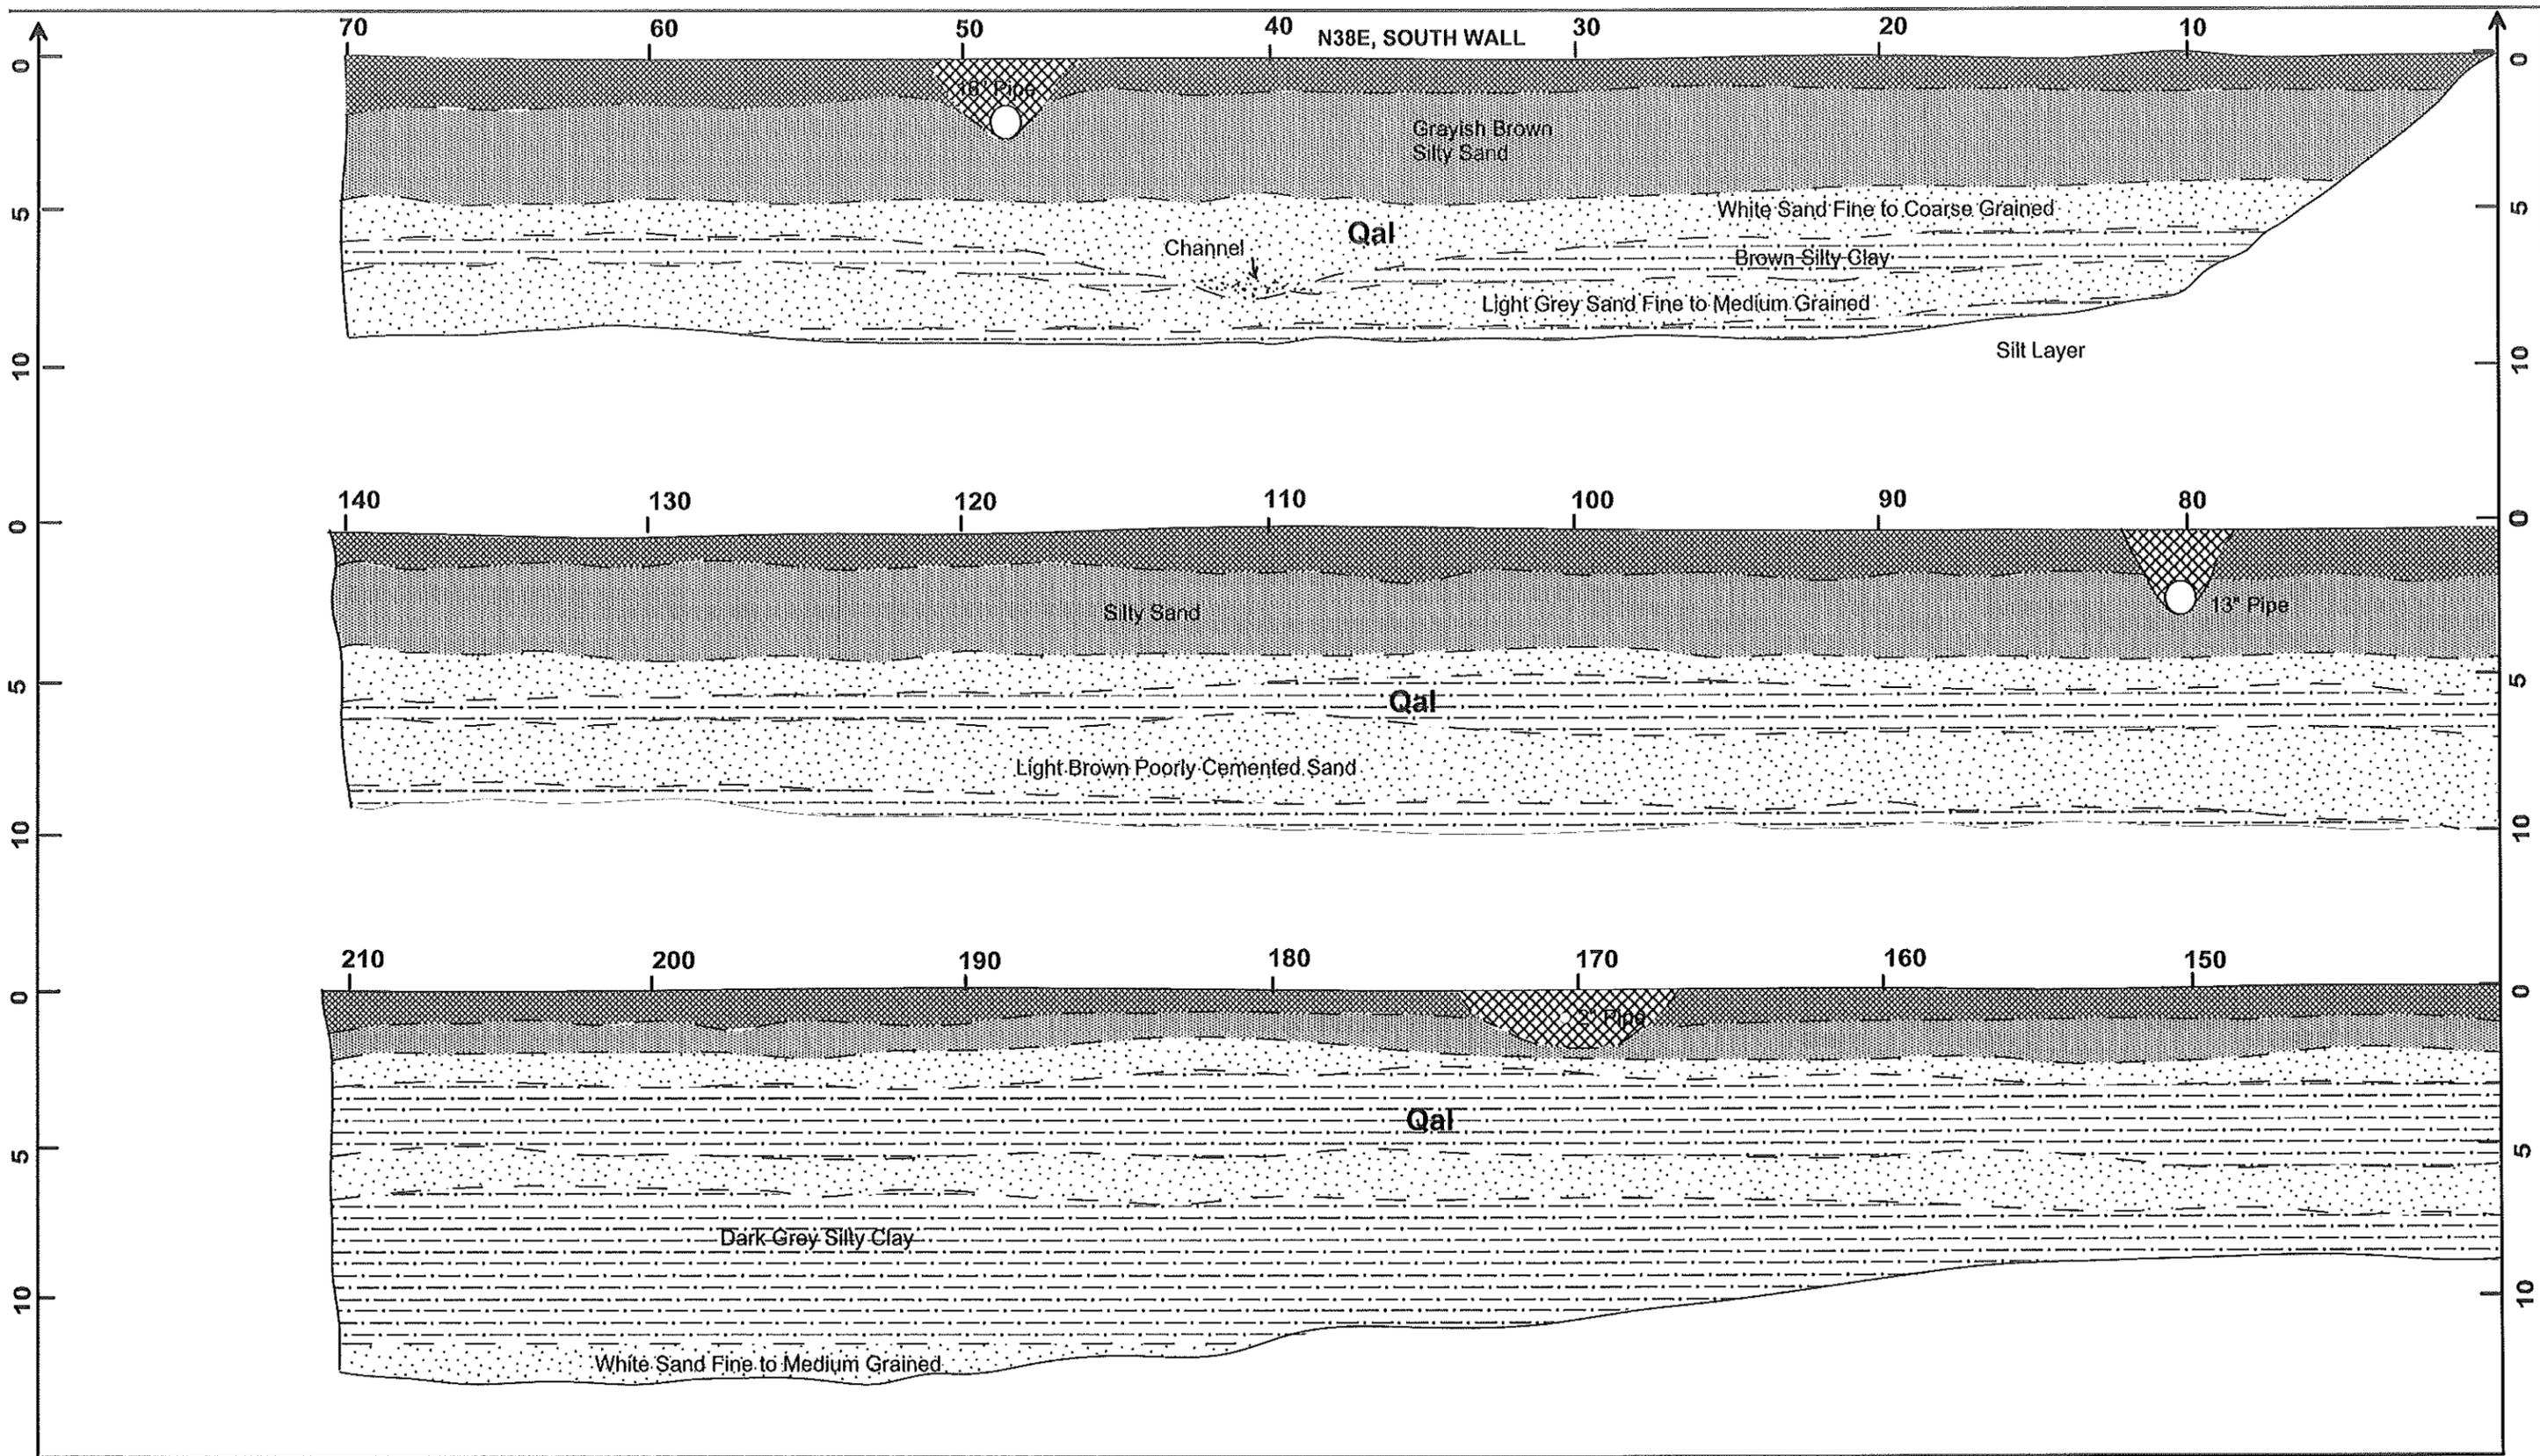
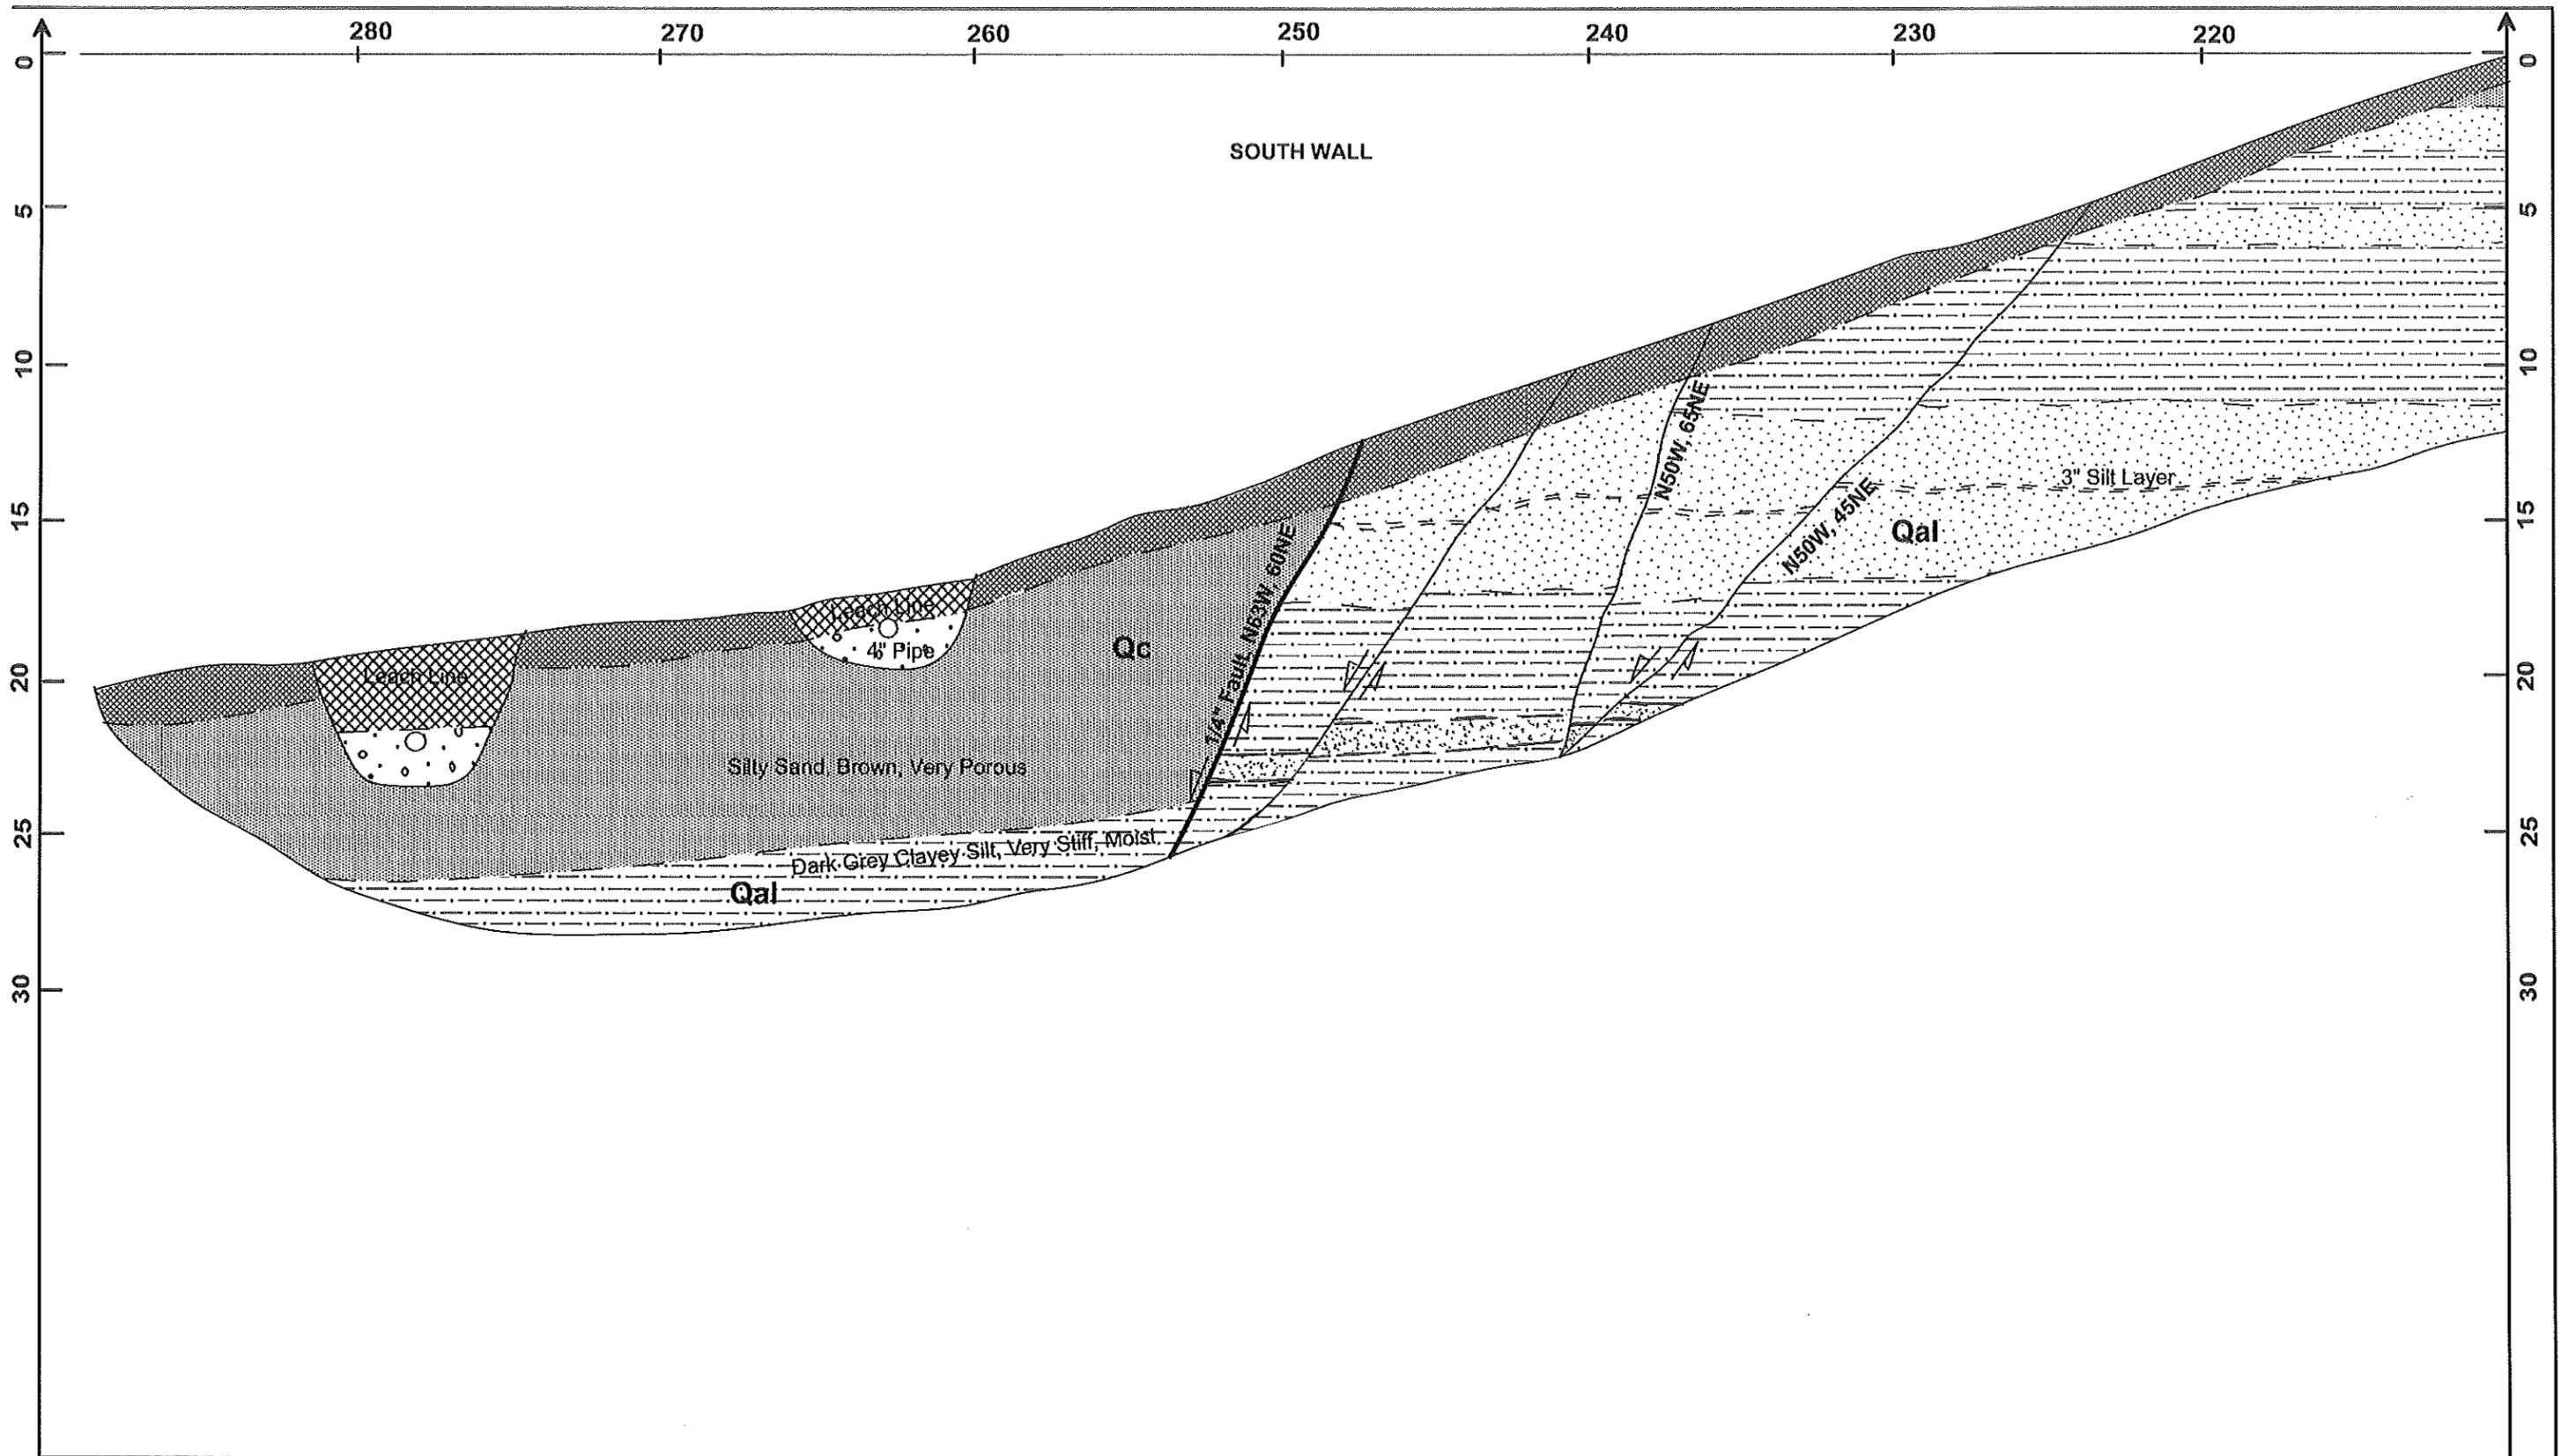
Evidence of fault rupture was observed up to the surface in both fault trenches. Therefore, the fault is considered to be an active fault, having undergone very recent and possibly historic surface rupture.

Major movement along the fault occurs along a narrow well defined zone. The strike of the fault measured in the bottom of the trench was approximately the same as the surface trace of the scarp. The attitude of the fault was N38W, dipping 65 degrees to the northeast in Fault Trench 1 and N63W, dipping 60 degrees to the northeast in Fault Trench 2.

The existence of a very prominent fault scarp at one confined location together with the narrow zone of sediment rupture near the surface observed in both on-site trenches indicate fault rupture has occurred in the past over a very narrow zone. Recurring faulting usually occurs along the same plane that underwent previous fault rupture.

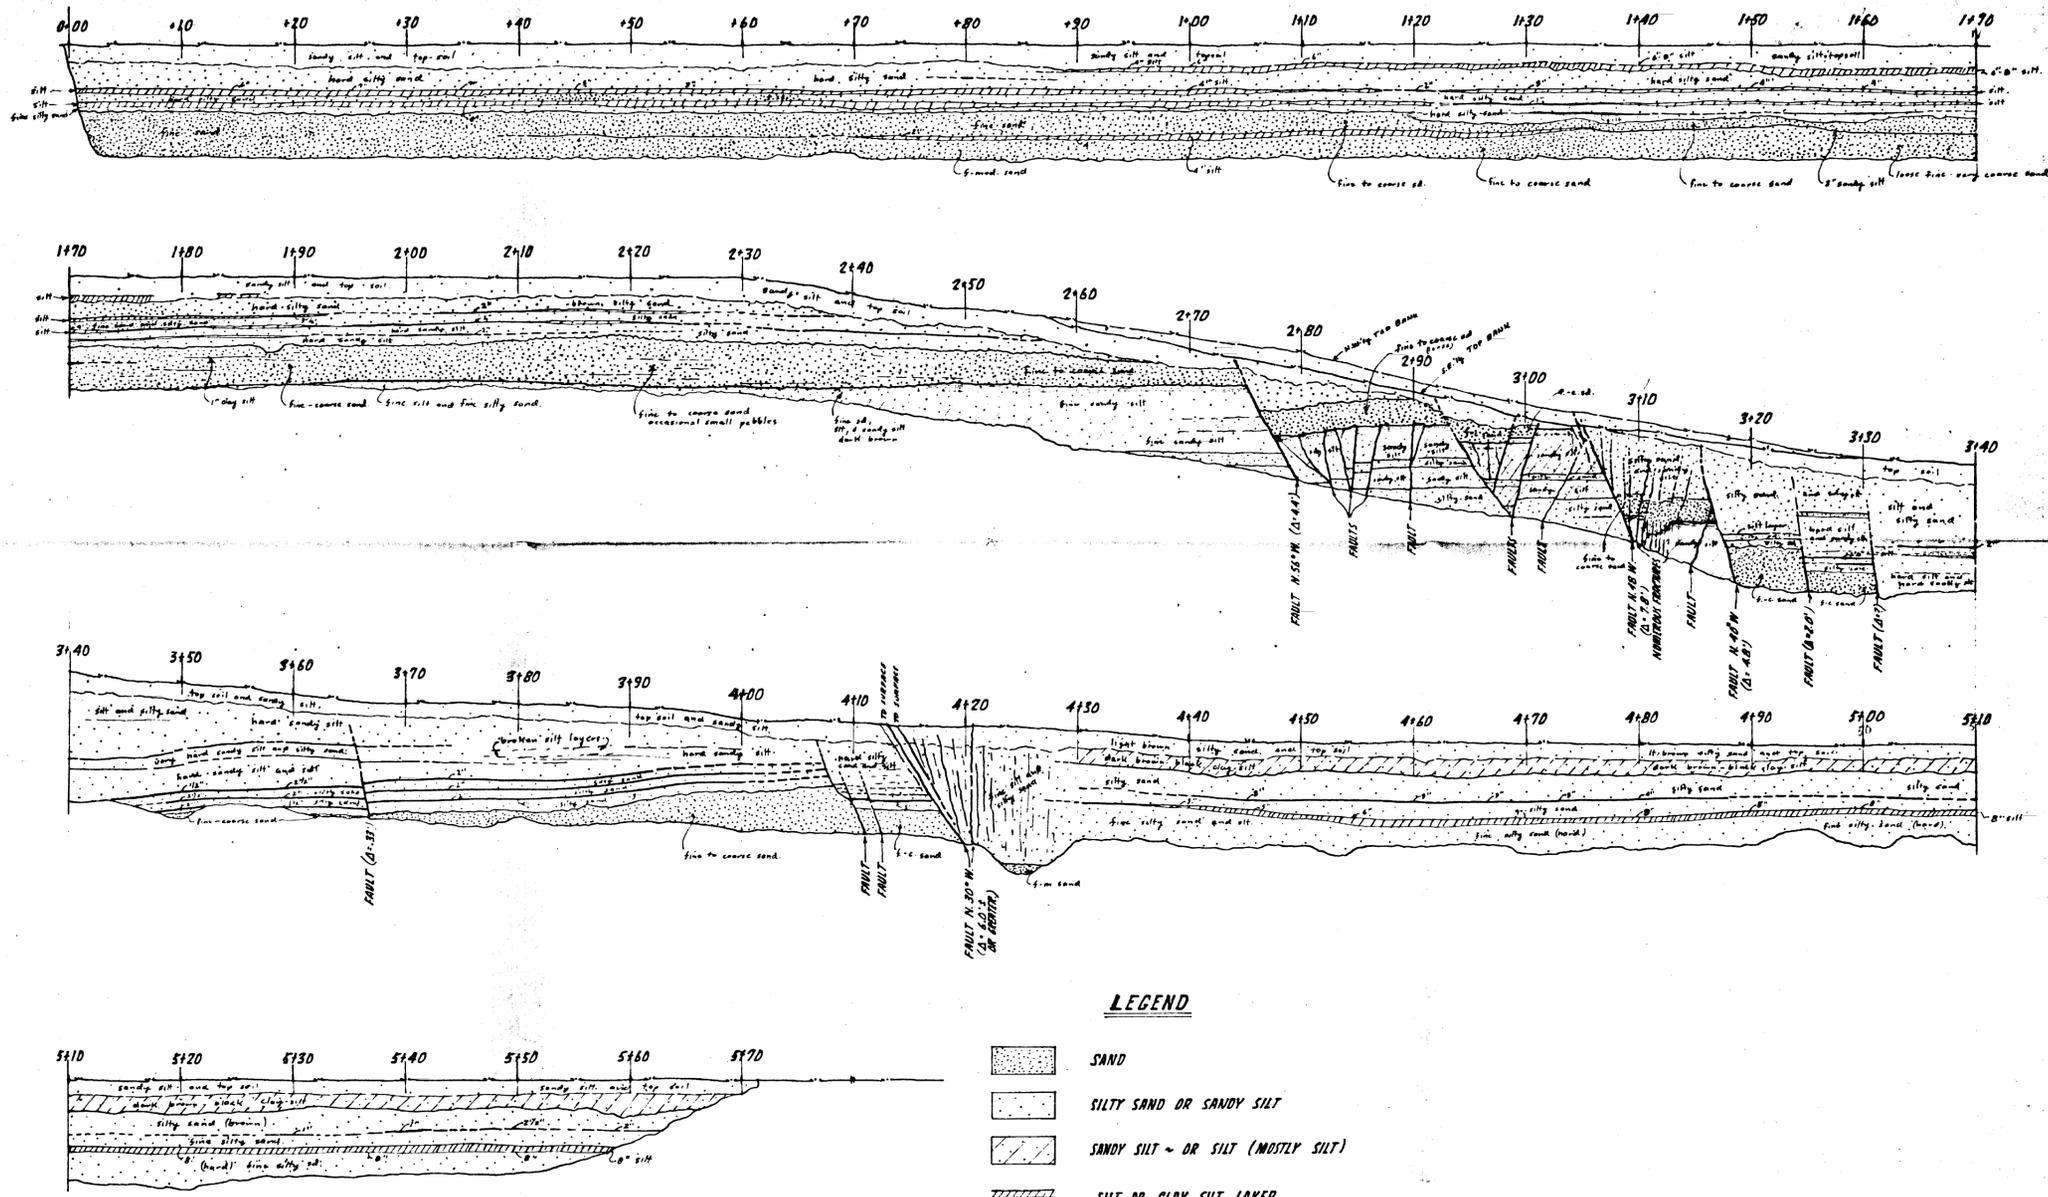
MAIN TRENCH (LOOKING NORTHWESTERLY)
 SCALE: 1" = 8' HORIZONTALLY AND VERTICALLY

From station 4+⁰⁷~~8~~ to station 4+30 several faults were observed. The most prominent of which occurred at station 4+15. The amount of displacement on this fault is unknown. From station 4+30 to 5+70 (the end of the trench) no displacement on a fault was observed).
