Project No.19-805 Fault

Subject: Response to Peer Review by Leighton Consulting dated April 3, 2020, Proposed S2A Showroom and Factory Compound, APNs 439-030-009, 439-030-010 and 439-400-023, West of State Street and Crow's Nest Place, City of Hemet, Riverside County, California

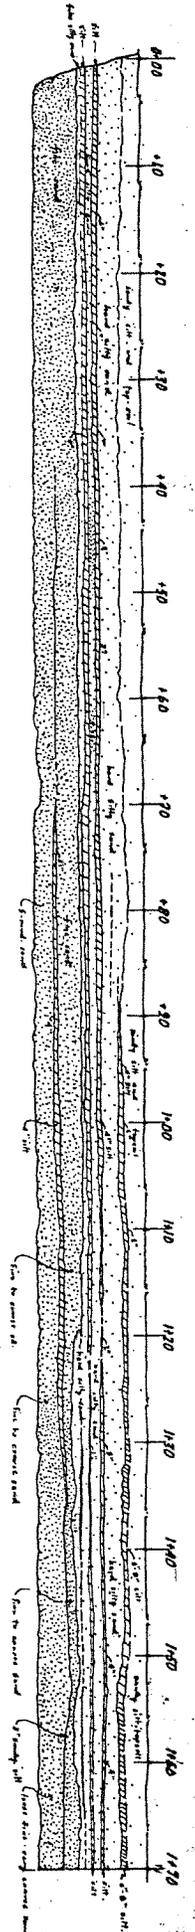
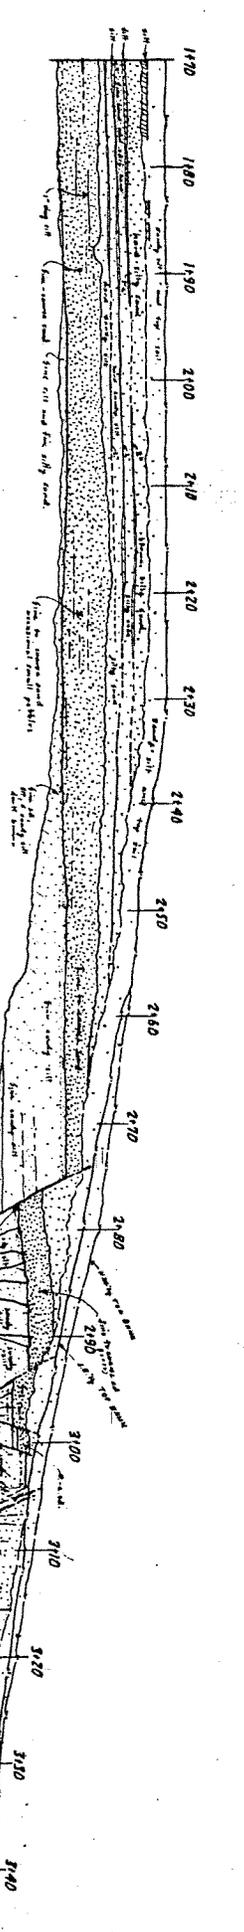
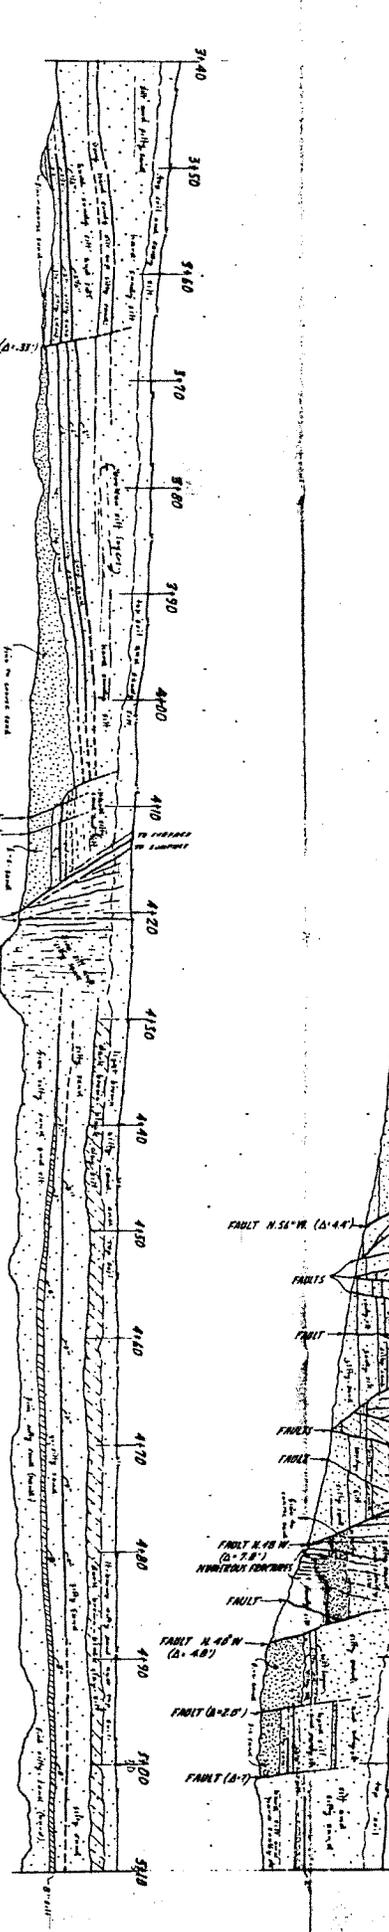
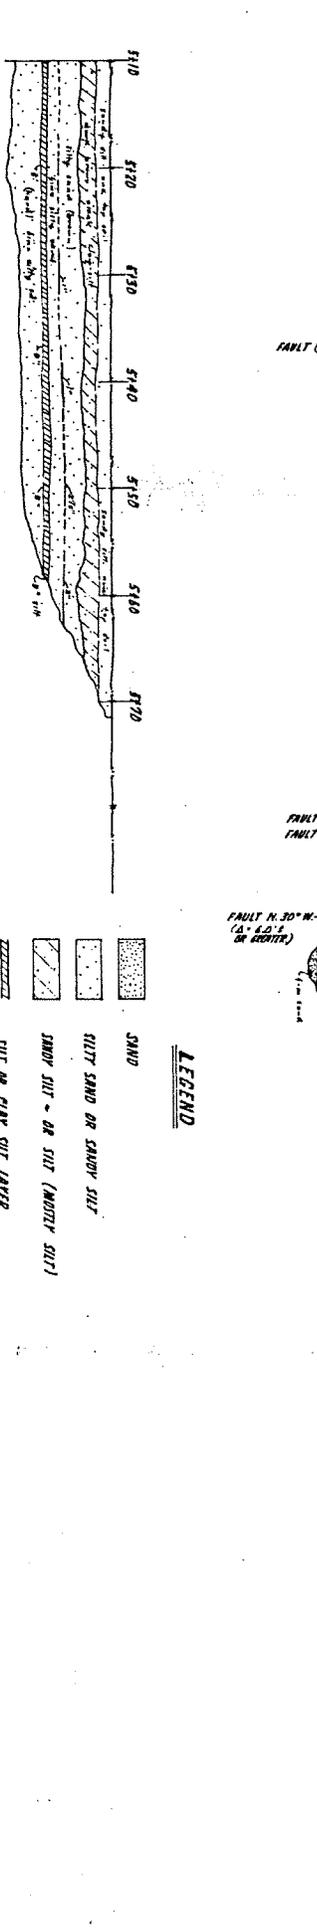
TRENCH CROSS SECTIONS

MAIN TRENCH (LOOKING NORTHWESTERLY)
 SCALE: 1" = 8' HORIZONTALLY AND VERTICALLY

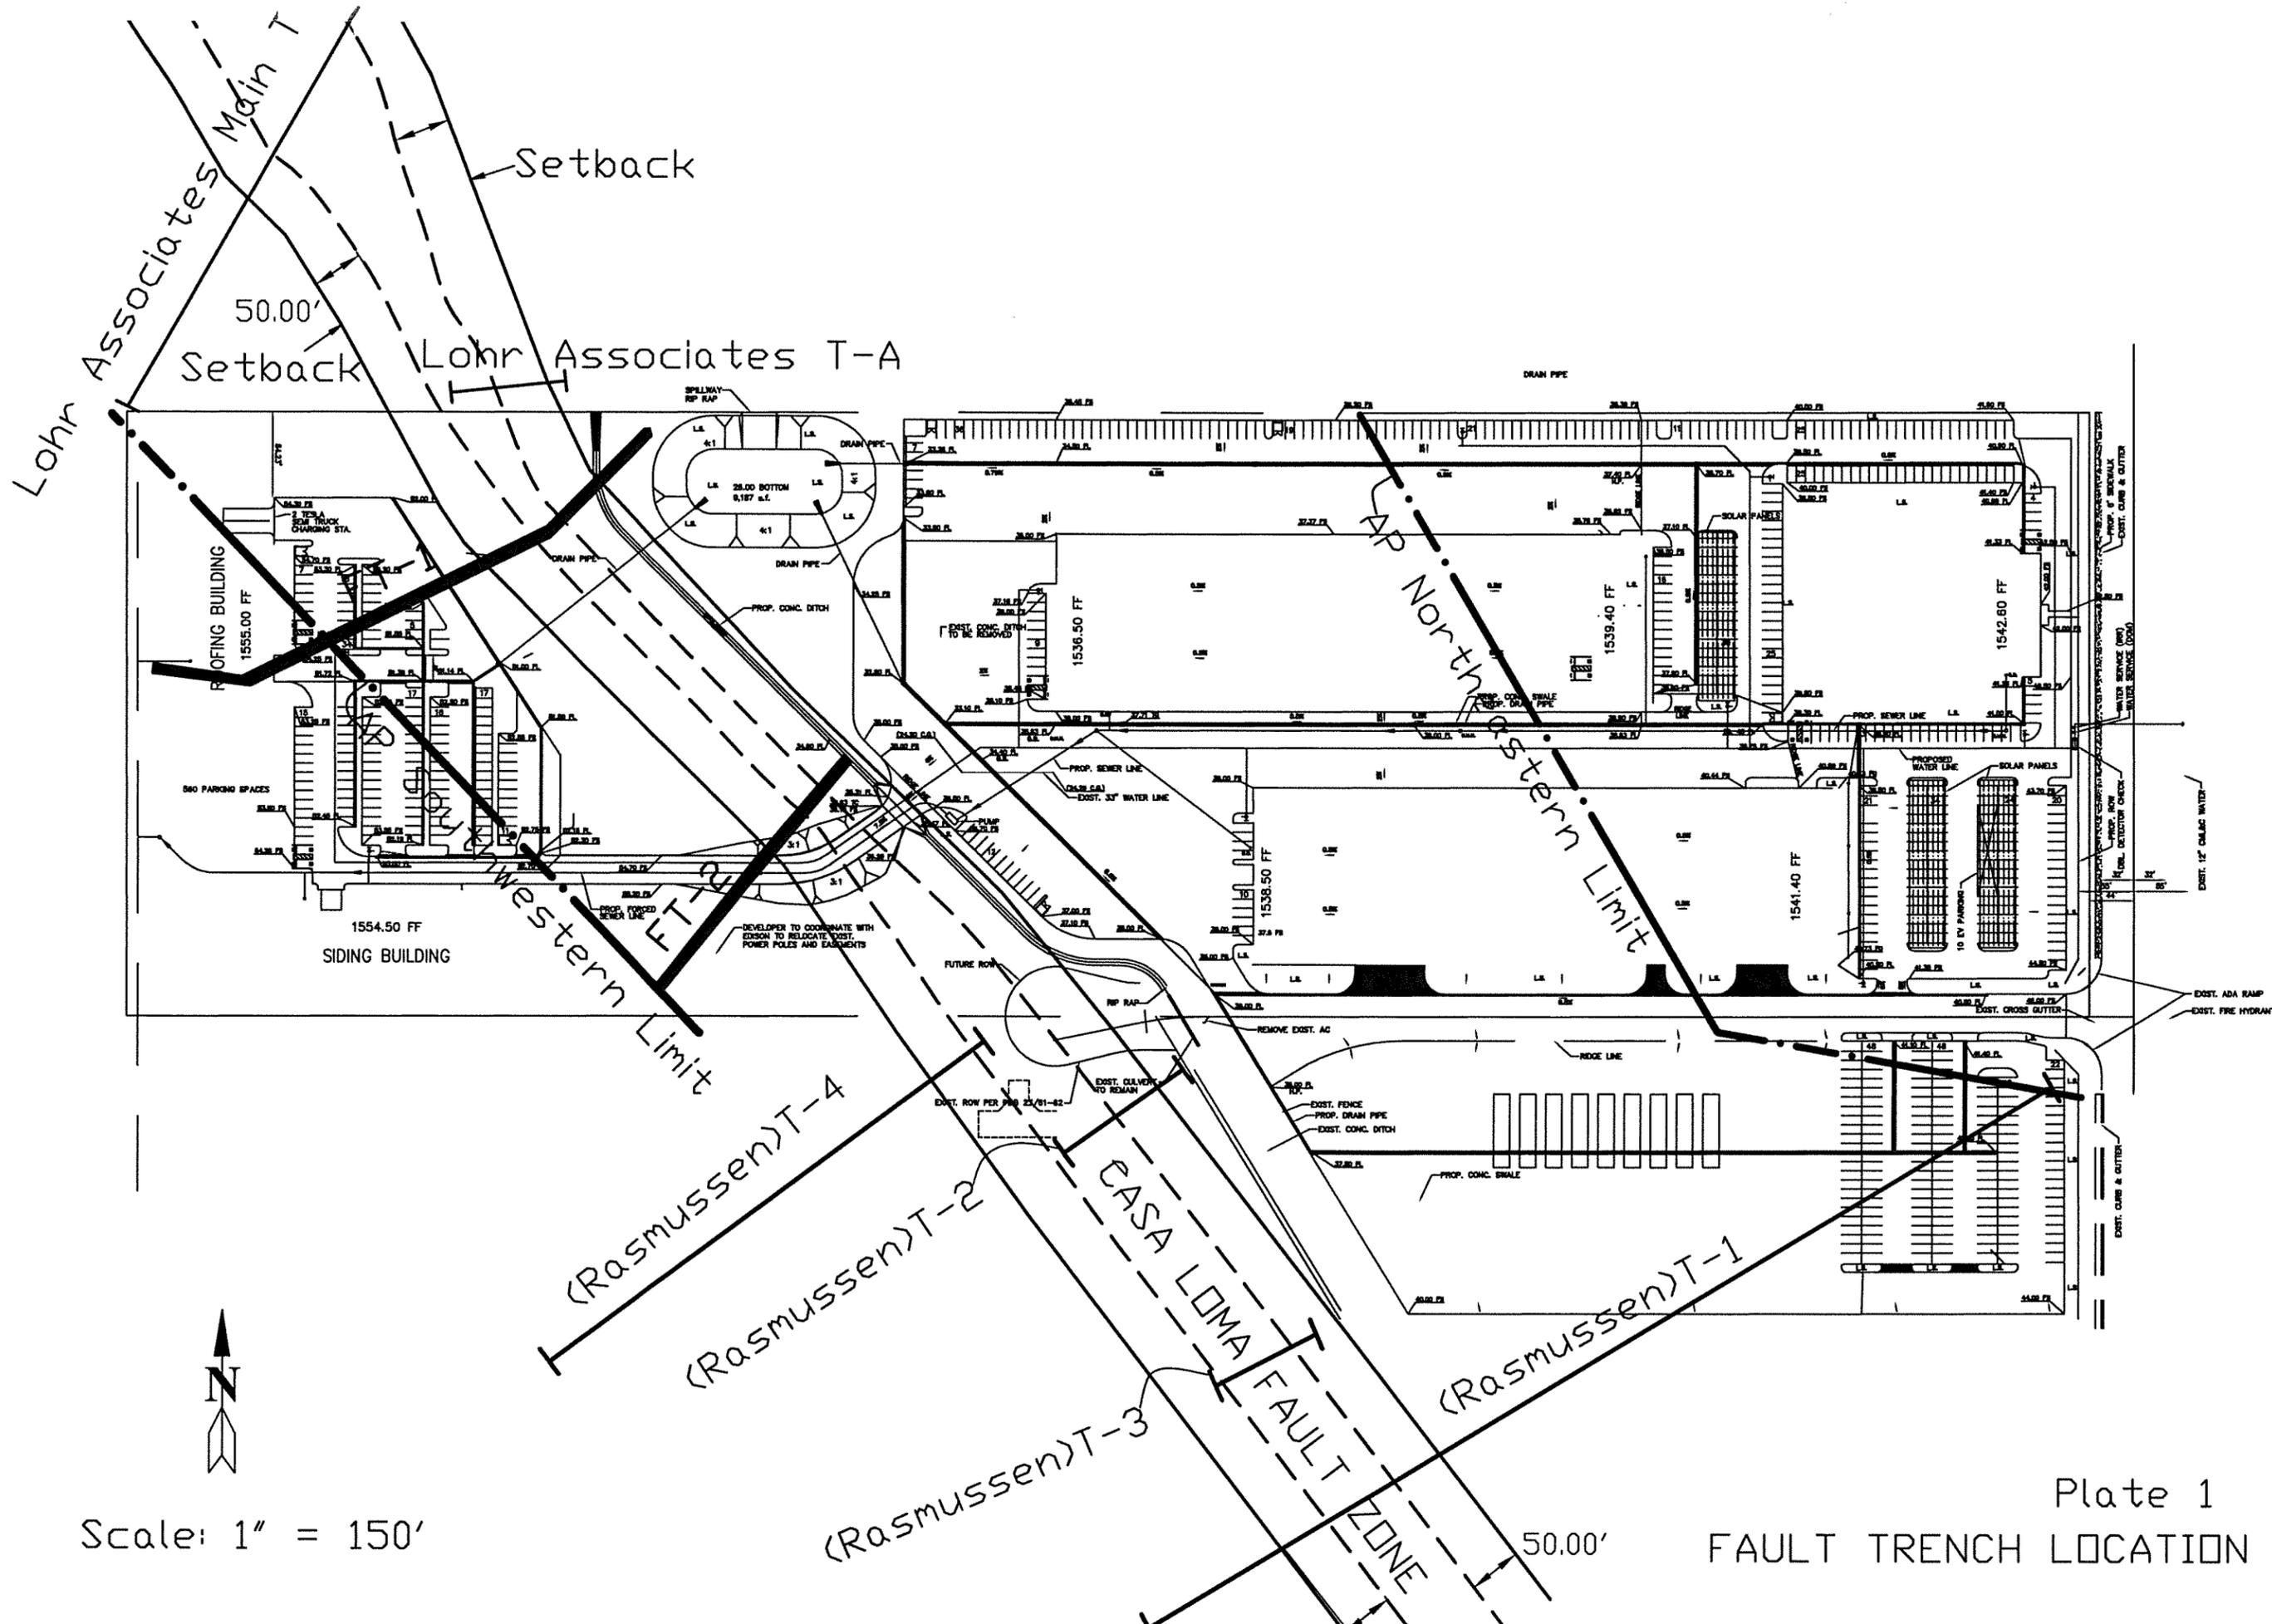
Plate 1
FAULT TRENCH LOCATION MAP

The engineering geology investigation prepared by Gary S. Rasmussen was located directly to the south of and included a portion of the subject site. Fault trenching was performed as part of their investigation. Applicable fault trench locations are presented on the Fault Trench Location Map, Plate 1.

The fault hazard report prepared by Lewis S. Lohr was located directly north of the subject site. Fault trenching was performed as part of their investigation. Applicable fault trench locations are presented on the Fault Trench Location Map, Plate 1.

The fault setback zone was adjusted at the north and south ends of the subject site to correlate with adjacent studies.

The limits of Alquist-Priolo zone are shown on the Fault Trench Location Map (Plate 1).

Fault trenching was performed by Rasmussen and Associates across the un-trenched portion of the AP zone in the northeast portion of the site. No evidence of faulting was noted in this area.

Ground lurching and lateral spreading could occur due to the differing elevations on either side of the fault. However, the hazardous effects during an earthquake should be confined to the same zone as would be disturbed by fault rupture (the zone between recommended set-back lines on the enclosed Plate 1).
