FRED AFLAKIAN, PG, CEG
CONSULTING ENGINEERING GEOLOGIST

Project No.19-805 Fault

Subject: Fault Rupture Hazard Investigation, Proposed S2A Showroom and Factory Compound, APNs 439-030-009, 439-030-010 and 439-400-023, West of State Street and Crow's Nest Place, City of Hemet, Riverside County, California

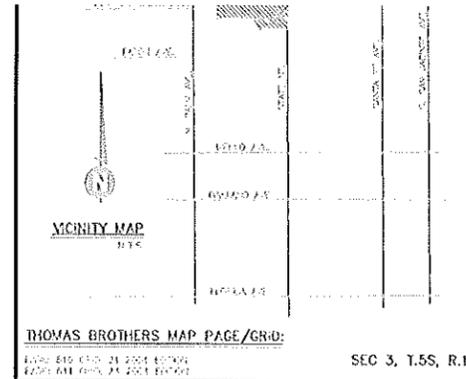
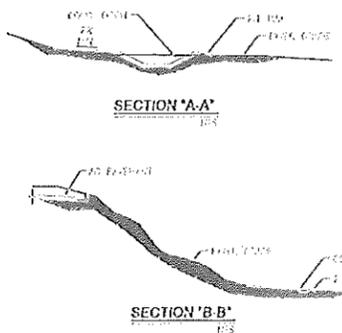
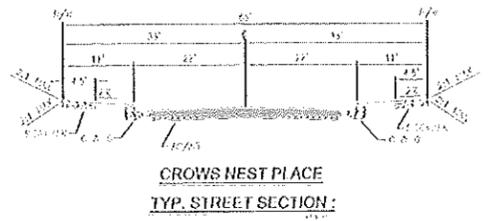
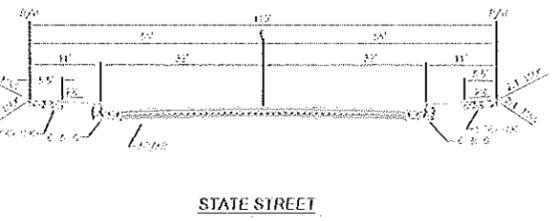
**PLATE 1
 FAULT TRENCH LOCATION MAP**

The surface locations of the major fault break were mapped. The mapped trend of the fault, as shown on Plate 1 (Fault Trench Location Map) was based on both the trend of the fault in the fault trenches as well as the trend of the fault scarp based on our review of aerial photographs. Human occupancy structures are not recommended across or within the designated fault setback zone as shown on Plate 1, Fault Trench Location Map.

Structures for human occupancy should not be placed in or across the designated fault setback zone shown on the enclosed fault trench location map (Plate 1).

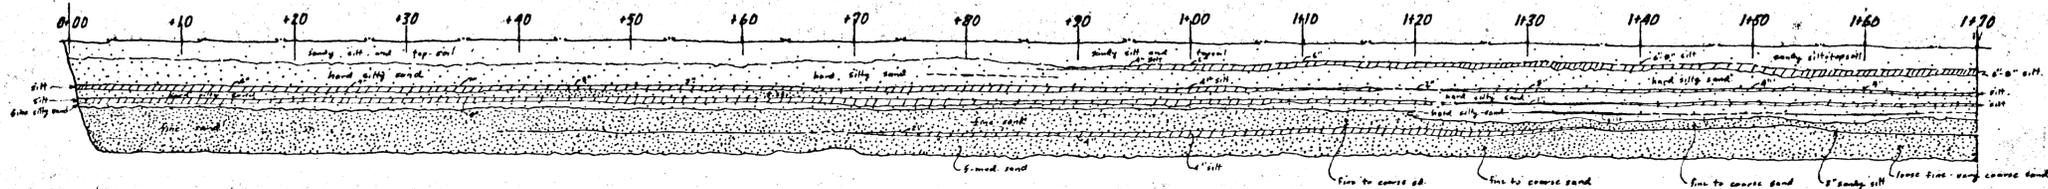
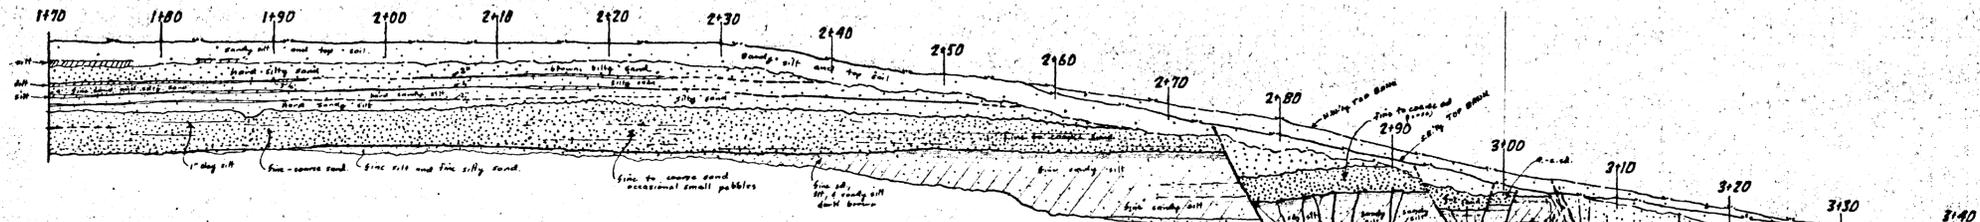
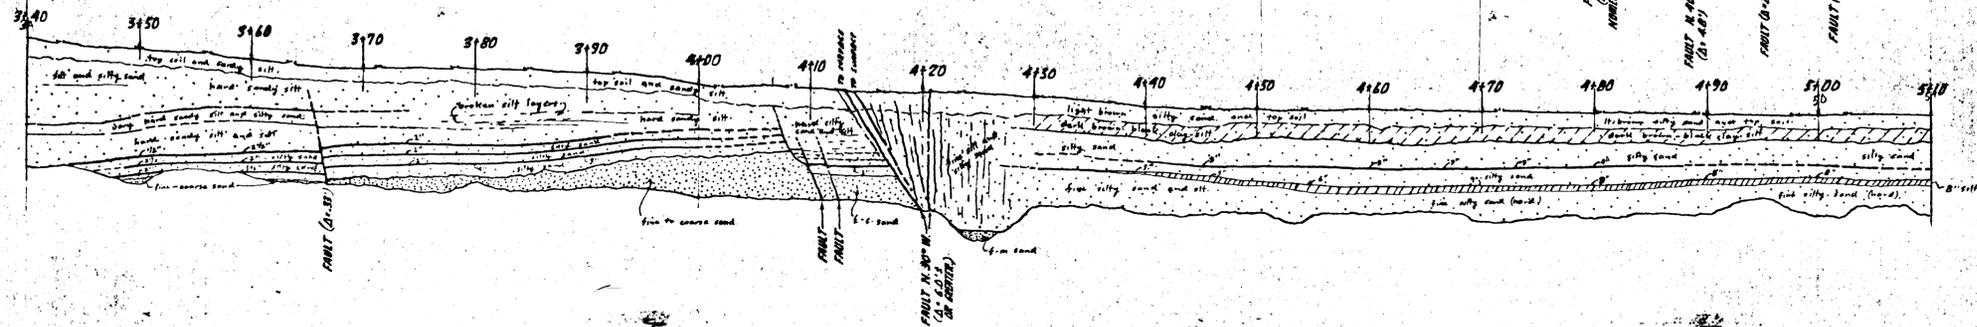
PLATE I

The property studied in this report is crossed by the Casa Loma Fault which has as its geomorphic expression an apparent scarp with a height that varies from 16 to 20 feet (4.9 to 6.1 M.). At the foot of, and along the face of this scarp are numerous fault related features such as sumps, small scarps, collapsed fissures, partially filled "blow holes", and cracks and disturbed ground. All of these features were in an area which was later shown by the subsurface investigation to be under the displacement influence of the Casa Loma Fault.
