Limited Geotechnical Evaluation

Stetson Corner Project

3145 and 3255 W Stetson Avenue
Hemet, California

March 13, 2020 | Project No. 109003001

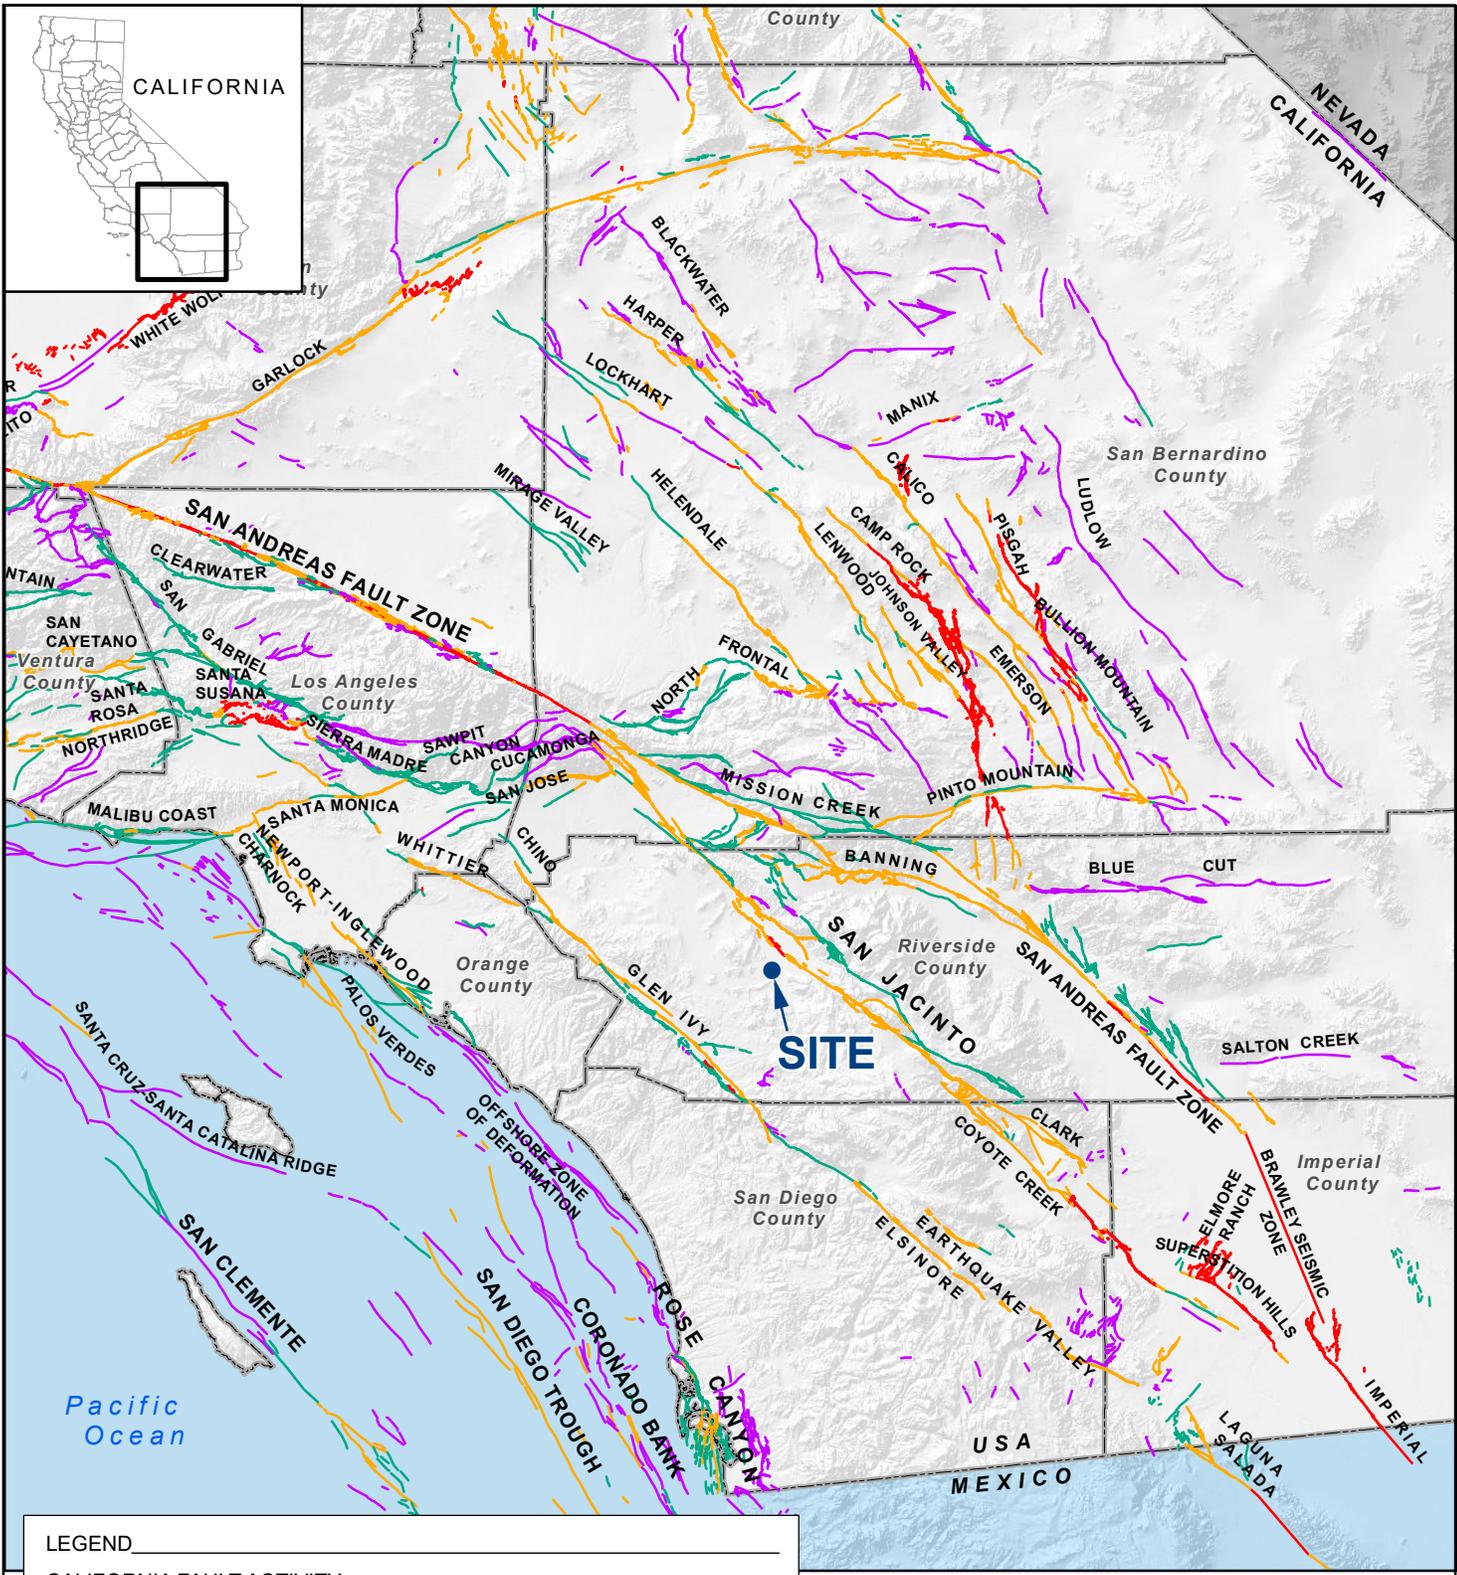
HISTORICALLY ACTIVE	QUATERNARY (POTENTIALLY ACTIVE)
HOLOCENE ACTIVE	STATE/COUNTY BOUNDARY
LATE QUATERNARY (POTENTIALLY ACTIVE)

Based on our review of the referenced literature and our field reconnaissance, no active faults are known to cross the project site. Therefore, the probability of damage from earthquake surface ground rupture is considered to be low. However, lurching or cracking of the ground surface as a result of nearby seismic events is possible.

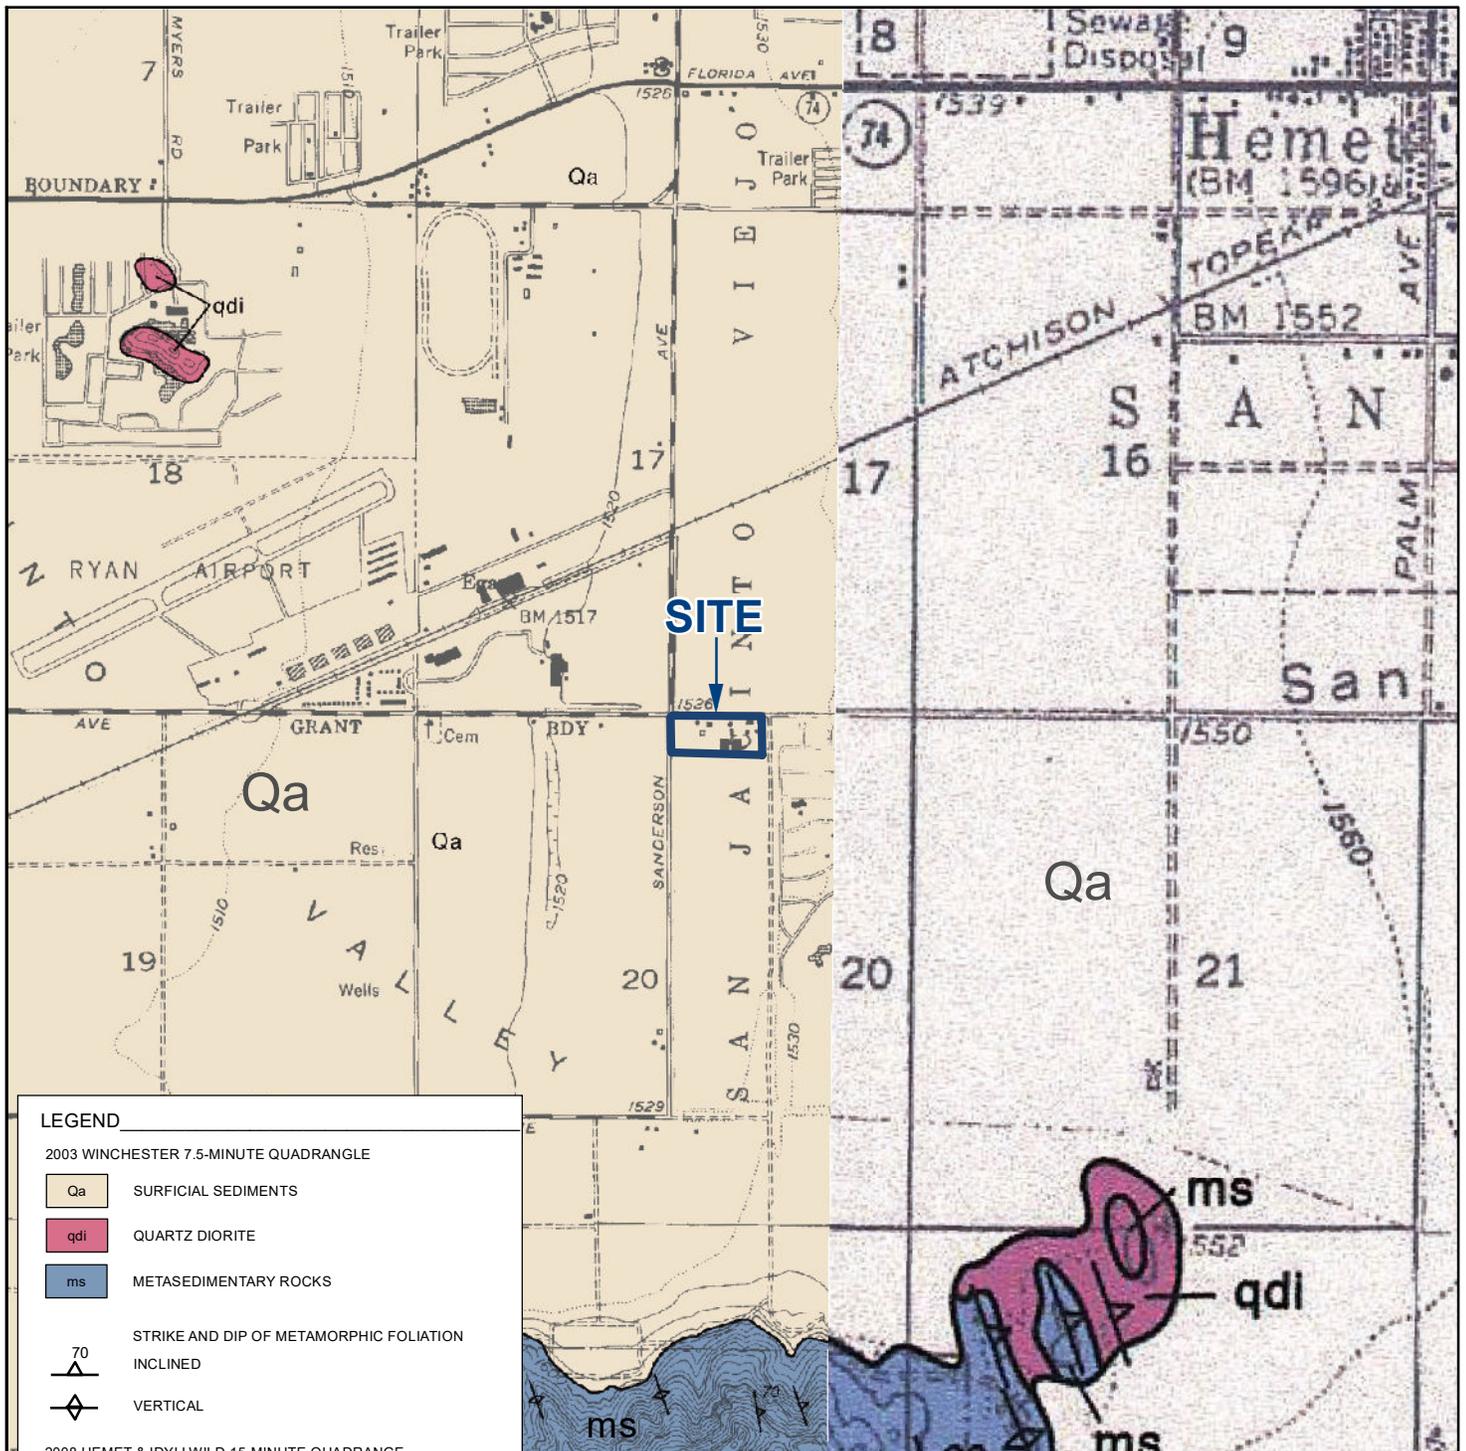
2003 WINCHESTER 7.5-MINUTE QUADRANGLE

Surficial alluvium including silt, sand and gravel of valley areas (Qa) is mapped at the site (Figure 4) and is anticipated to underlie the fill soils. As described in the geotechnical investigation by Sladden Engineering (2017) alluvium encountered below the fill consisted of dark yellowish brown, loose to medium dense, sand, silty sand, clayey sand and gravelly sand, and stiff to very stiff, clayey silt. The alluvium extended to the total depths explored of approximately 51½ feet in the borings performed by Sladden Engineering.
